Property Condition Assessment

3030 Smith Rd.
Anywhere, OH 00000

5/7/2004

C-050704-1

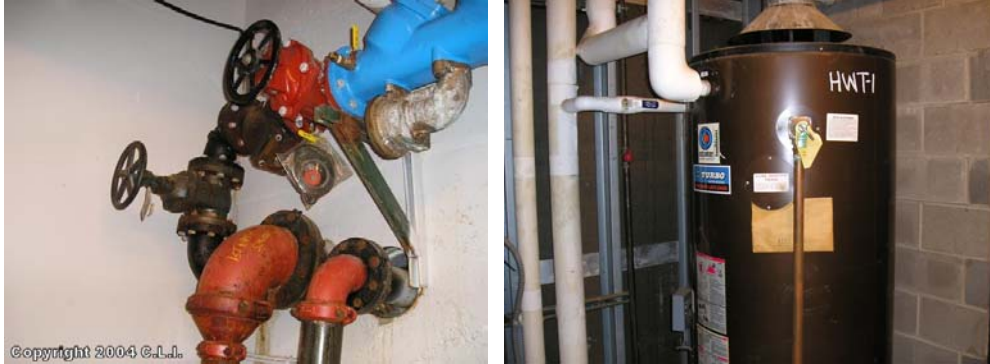
The main shutoff valve is located in the basement (See Photo Above).

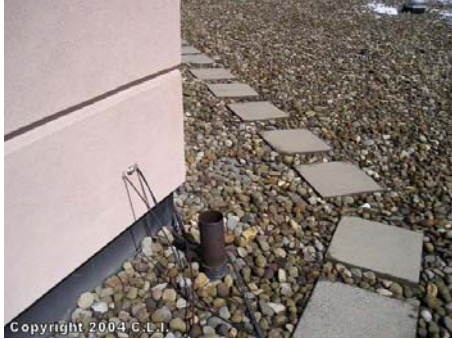
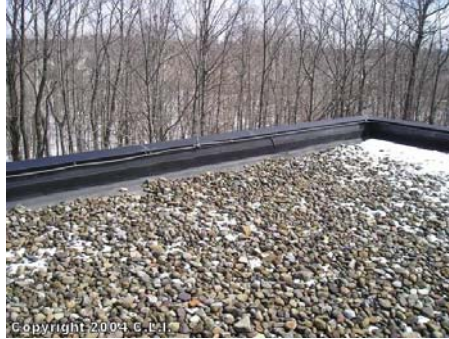
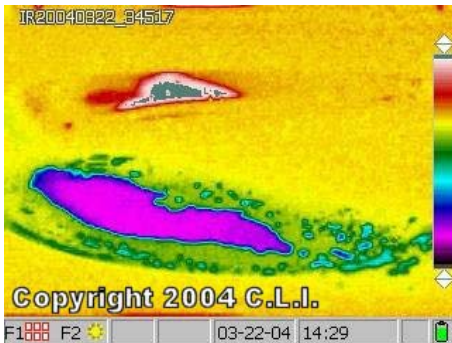
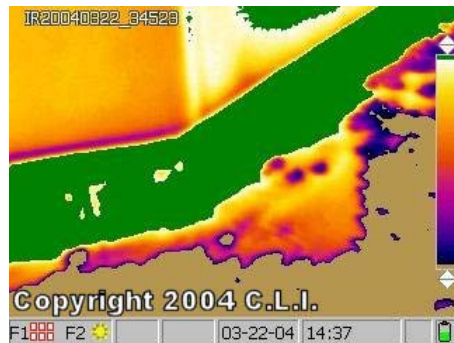
The flat roof is covered by a single-ply EPDM rubber membrane (See Photo #1 and above). The membrane is covered by large-stone ballast.

- 9.2.1 The ballast covered EPDM membrane roof cover appears to be in serviceable condition. There is evidence of leakage in several areas and evidence of past repairs.
- 9.2.2 It is suggested that an annual infrared roof survey be performed from the rooftop annually to assure roof integrity and repair schedule.
- 9.2.3 The EPDM roof cover is in the 12th year of a 18 year life expectancy.

Recommendations		Costs	Time Frame
9.3.1	General roof repairs.	Over \$10000	Immediate
9.3.2	Re-roof the entire building (approx. 39,000sf).	Over \$150,000	Five Years

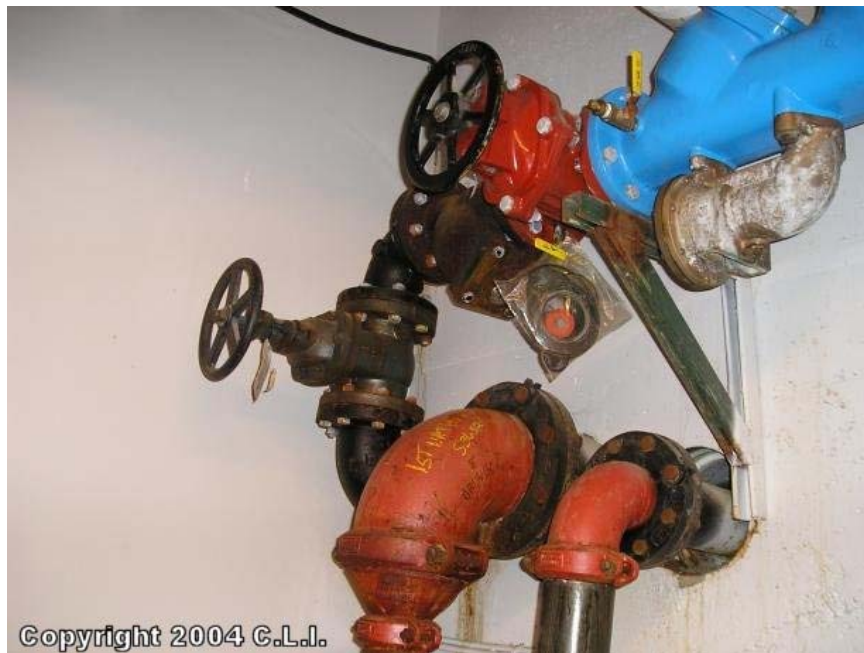
Photo 2: Main domestic water service entrance

- 8.2.1 No major deficiencies were noted in the plumbing system during the assessment. The location of the main water line to the property was not determined.
- 8.2.2 The State, gas fired hot water heater is estimated to be 13+ years of age. This unit may require replacement in the short term.

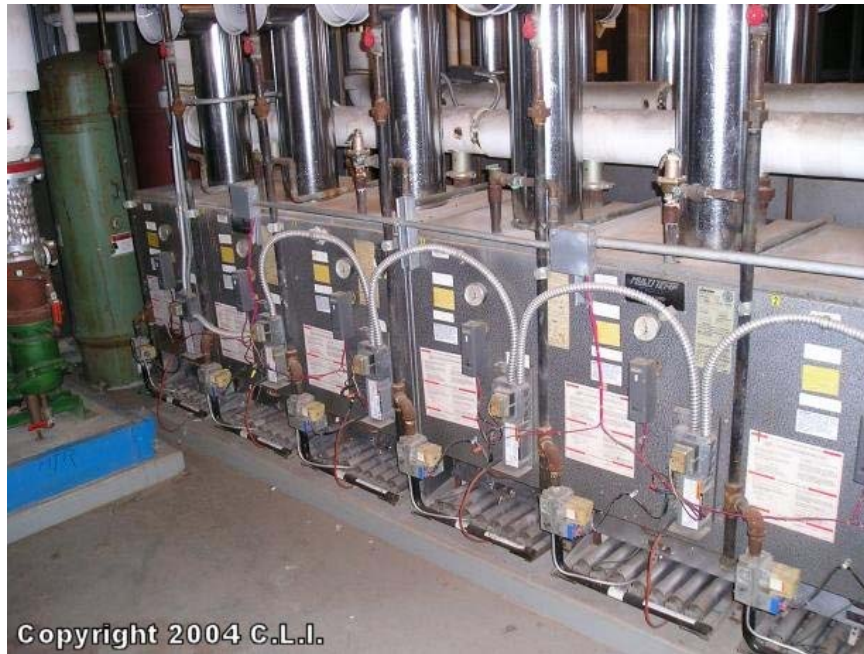
Photo 3: Main heating equipment

5.2.1 All boiler components appear to be well maintained and operating properly.

Recommendations		Costs	Time Frame
5.3.1	Service heating equipment.	Minor	Discretionary (as needed)

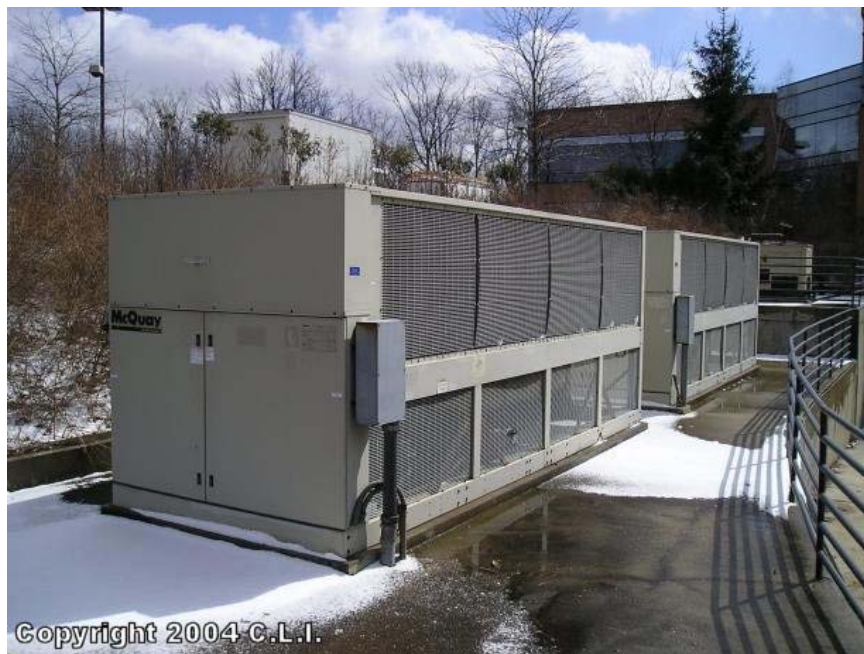
Photo 4: Main air conditioning equipment

- 6.2.1 The chillers are in the 12th year of a 15-20 year life cycle. Reserve funds should be anticipated for repairs and maintenance.

Recommendations	Costs	Time Frame
6.3.1	Service air conditioning equipment.	\$3000 - \$4000
		Three Years

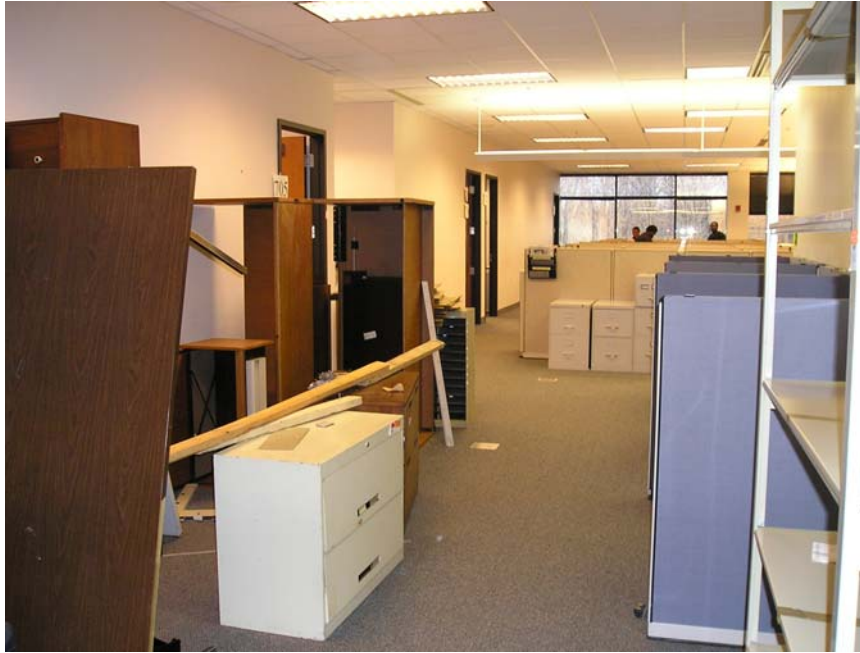
Photo 5: Typical building interior

10.2.6 Water stains were noted at several locations. The locations of staining and the suspected sources of moisture are as follows:

Location of stain	Suspected source
Main entrance foyer ceiling	Roof leak
Office Area	Condensation

Recommendations	Costs	Time Frame
10.3.1 Replace water damaged ceiling tiles.	\$3000 - \$4000	Immediate
10.3.2 Provide damproofing and drainage tile for foundation adjacent to basement stairwell.	Over \$10000	Immediate

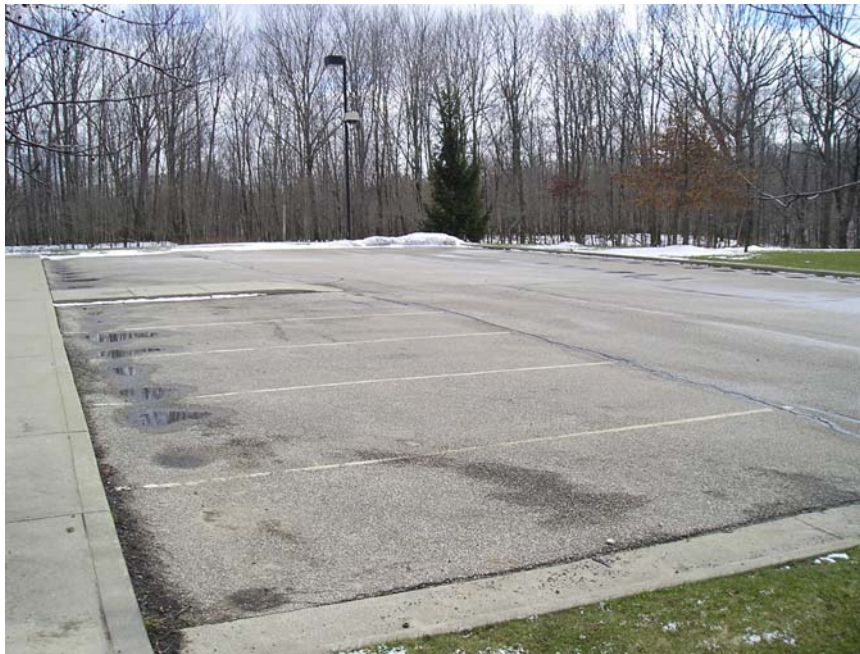
Photo 6: Building parking area section

- 11.2.10 Localized areas of surface deterioration at the drive and parking areas should be renewed.
 11.2.11 The areas of surface deterioration at the parking areas and drive should be renewed. This should include seal-coating and re-striping.
 11.2.12 Concrete curbs are damaged in various locations and should be repaired.

Recommendations		Costs	Time Frame
11.3.1	Recaulk expansion joints.	\$3000 - \$4000	One Year
11.3.2	Repair grading in various locations	\$5000 - \$6000	Immediate
11.3.3	Asphalt paving repairs at various location. Includes seal-coating and re-striping	Over \$20000	One Year
	Rebuild damaged retaining wall around	Over \$20000	Immediate

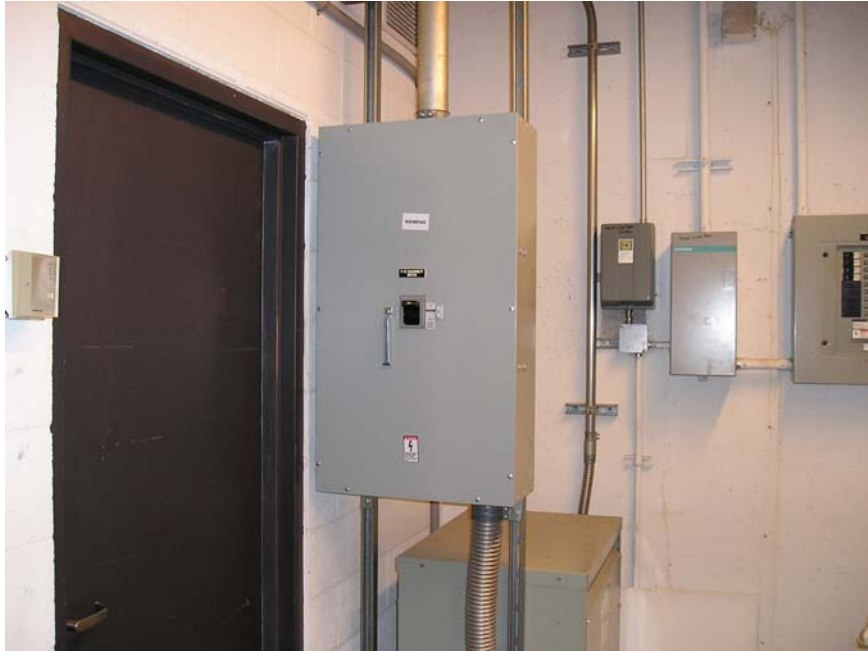
Photo 7: Main electrical service equipment

- 4.2.1 There are no material deficiencies requiring repair or replacement at this time. Maintenance representative reports no electrical problems.
- 4.2.2 It is suggested that an infrared (Thermographic) survey be performed on the system annually.
