Buildings Are Getting Greener, But Are They Getting Better?

Do Green Labeled Building Materials or Certification Guaranty Success?

Al Tibbs, LEED AP, CIEC, CIAQT C.L.I. Group, LLC Cleveland, Ohio

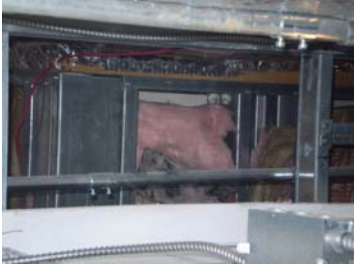
The building shown in the photo on the left was suffering from comfort issues, condensation problems and frozen sprinkler pipes. This building was found to be suffering from many issues related to both design and installation. The building was conditioned using two heat pumps with air handlers installed in drop ceiling area close to where the photo was taken. A visual inspection of the ductwork and air handlers revealed visible leakage in both supply and return ducts and limited (R2) insulation on ducts. This building was acting as a connector between two main buildings. The building pressures were evaluated with reference to both outdoors and the two connecting buildings, and were severely negative with reference to both.

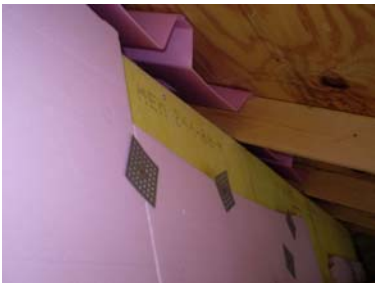
Another photo from the same project shows polystyrene insulation which does not cover the sheathing to top of wall. In addition, the exposed sheathing has exposed joints, which allows for additional air leakage and thermal bridging. The problems in this building were exacerbated by steel stud framing and poor batt insulation installation. This building illustrates the fact that although modern materials are used, negligence during installation can erase any added value of using quality materials.

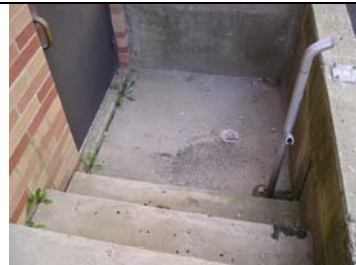
Figure 2 Below grade door to classroom

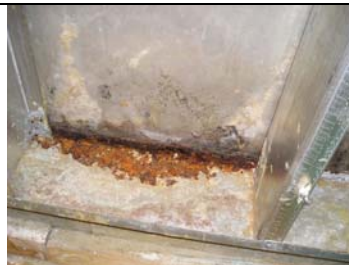
Figure 3 Inside exterior wall cavity

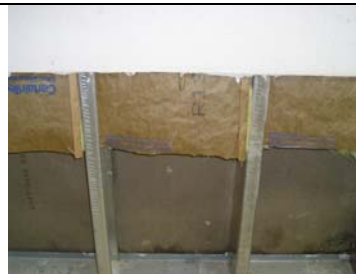
Figure 4 Steel stud, batt insulation, water damage

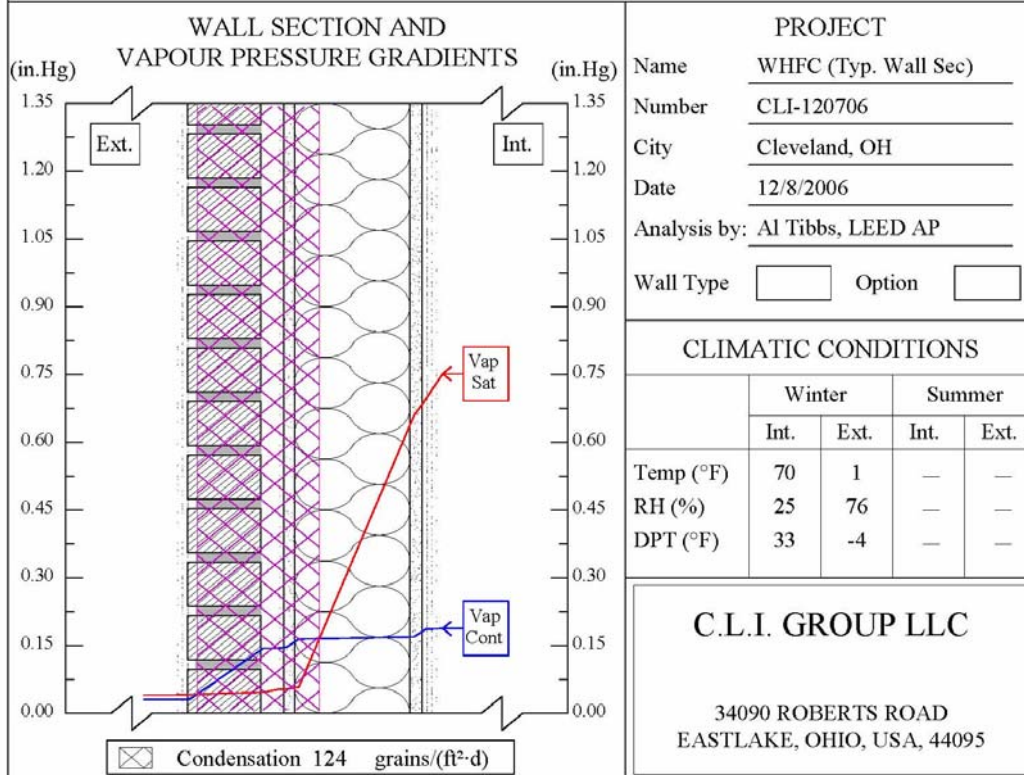
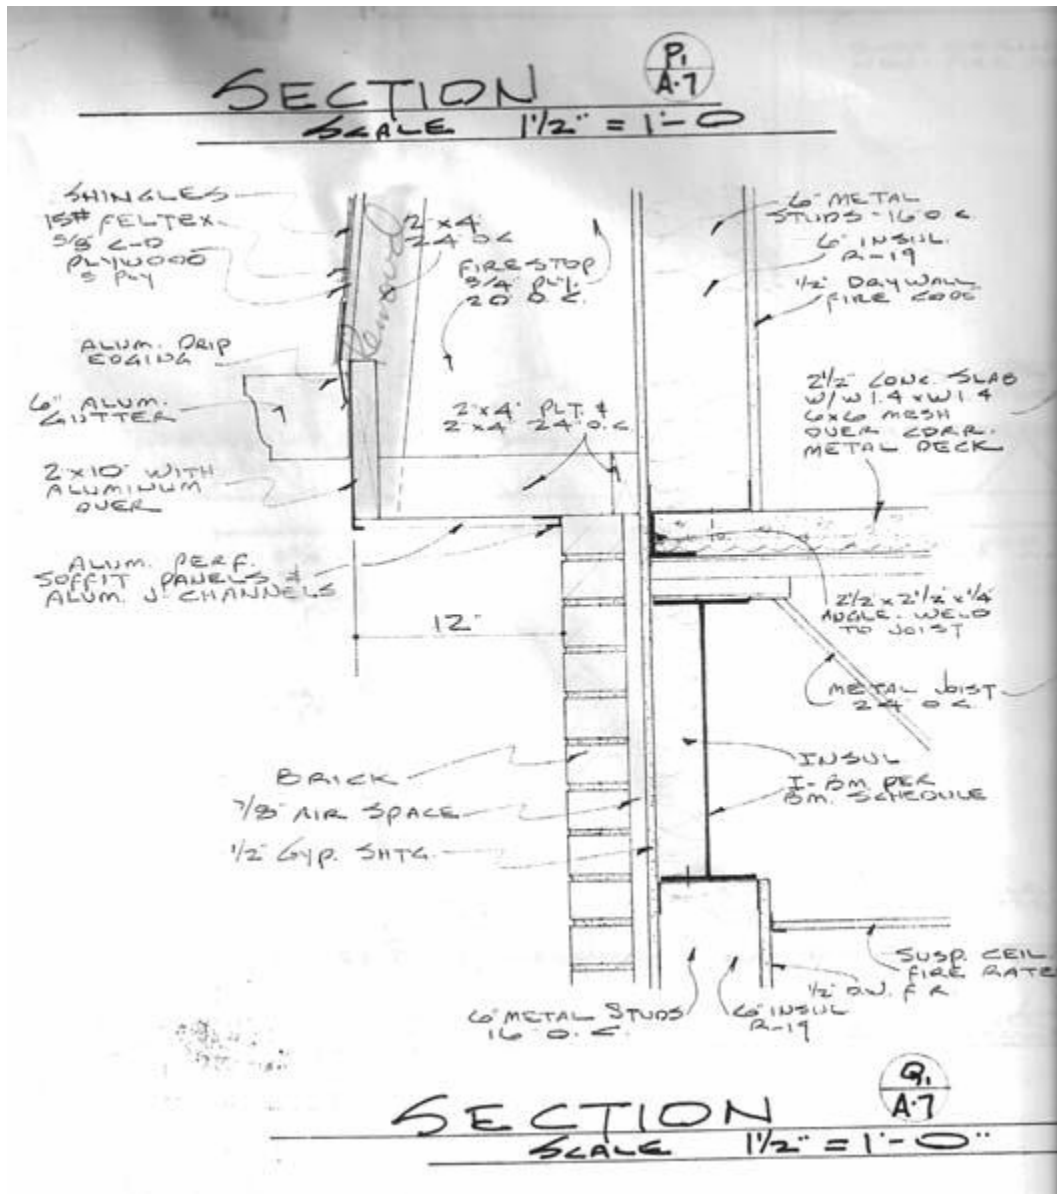
CONDENSATION ANALYSIS

The condensation analysis indicates that dew point is being reached within the fiberglass batt insulation. This leaves the inside face of exterior sheathing and steel studs as first condensing surfaces. When performing an evaluation of the plans we noticed several areas of concern. Below are some of those concerns:

1. The airspace behind the masonry veneer was $\frac{3}{4}$ ". This is inadequate for several reasons. It allowed the space to be clogged by grout from wall during construction. Poor drainage plane.
2. There is no exterior insulation (continuous insulation).
3. Steel studs, no exterior insulation, poorly installed fiberglass batts and poorly installed air barrier allow for air leakage of humid outdoor air in summer and lowers interior surface dew points in summer.
4. Depressurization due to imbalances in mechanical systems are allowing drop ceiling plenums to pull return air through building enclosure instead of conditioned space.
5. 6 inch steel stud wall does not allow for adequate insulation for this application. Reduced resistance due to air infiltration/wind washing.

6. No mortar blocking installed (e.g. Mortar Net) to keep grout from blocking weeps.
