Building Moisture – Causes and Cures

Alfred L. Tibbs Jr., CIAQT
Closer Look Inspections Cleveland, OH

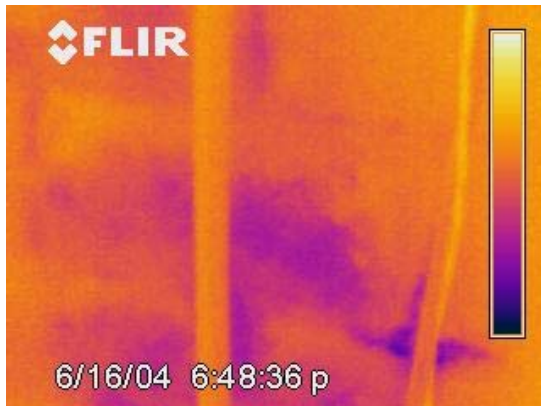
The image on the left was taken using infrared thermography during a recent assessment of a basement water problem. The home had already been inspected by a private company that diagnosed extensive basement moisture and recommended excavation, waterproofing and new drain tiles at a cost of approximately \$14,000. Needless to say, this frightened home buyer walked away from the deal. The homeowner contacted Closer Look Inspections to re-evaluate the problem and make repair recommendations.

Investigation and infrared thermography pinpointed the problem to the sump pump discharge line. The line was broken below grade and was pumping water onto the foundation wall (the line is indicated by lighter color in image, the darker color indicates colder temperatures/moisture).

The cost of repairing the broken discharge line from the sump pump was of course much less than excavating the entire foundation. This shows just one instance of misdiagnosis of a construction problem and the potential cost of such a diagnosis.

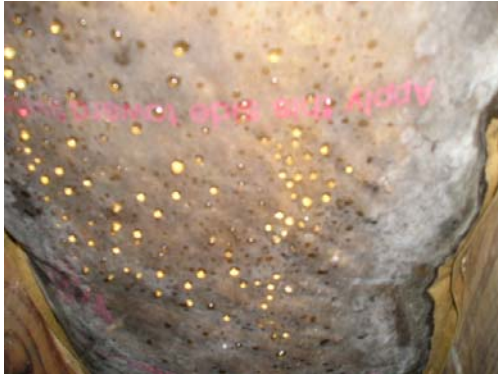
The photo on the left shows an extreme case of moisture buildup due to poor construction methods. The photo was taken in a small crawlspace under an addition on a home. The builder installed no vapor barrier on the soil and installed the vapor barrier improperly exposing the floor framing to extensive moisture. The conditions present on this particular project also led to extensive fungal contamination and rotting of wood framing members.
