Crawlspace/Foundation Assessment

00000 Anystreet (Yourtown, USA)

Date 12/3/2004

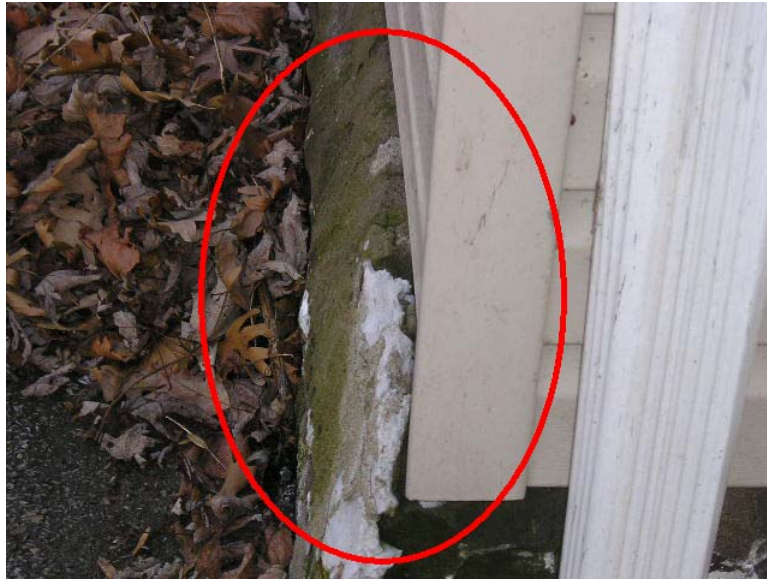
Foundation at rear, drive side of structure indicates bowing/movement of foundation.

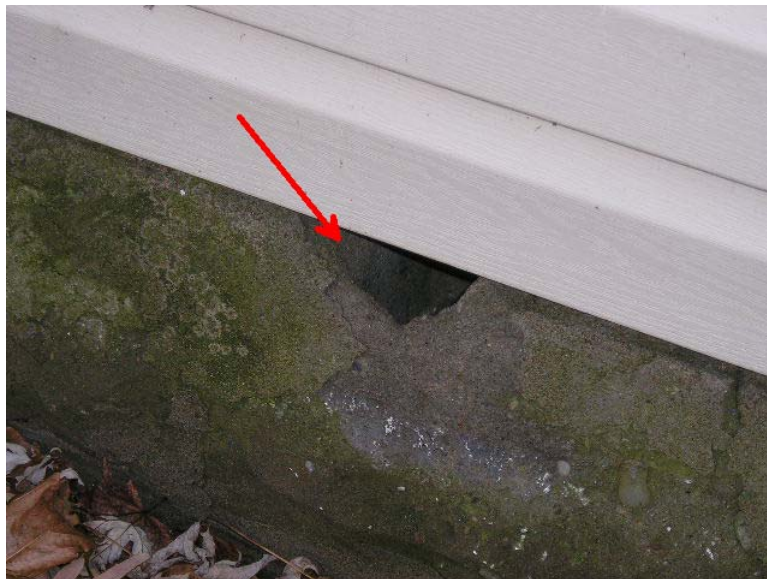
Pointer shows area of foundation at rear, drive side corner which is damaged due to movement and/or moisture.

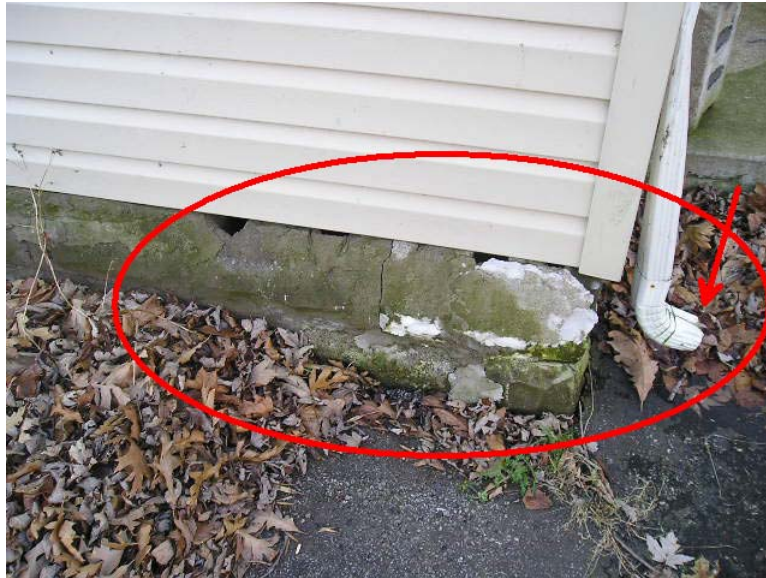
Another view at rear, drive side corner shows significant damage/movement of the foundation. Note that the downspout terminates at foundation. This home has missing gutters in many locations and downspouts which terminate at foundation. These conditions are directing large amounts of water toward the foundation and into the crawlspace.

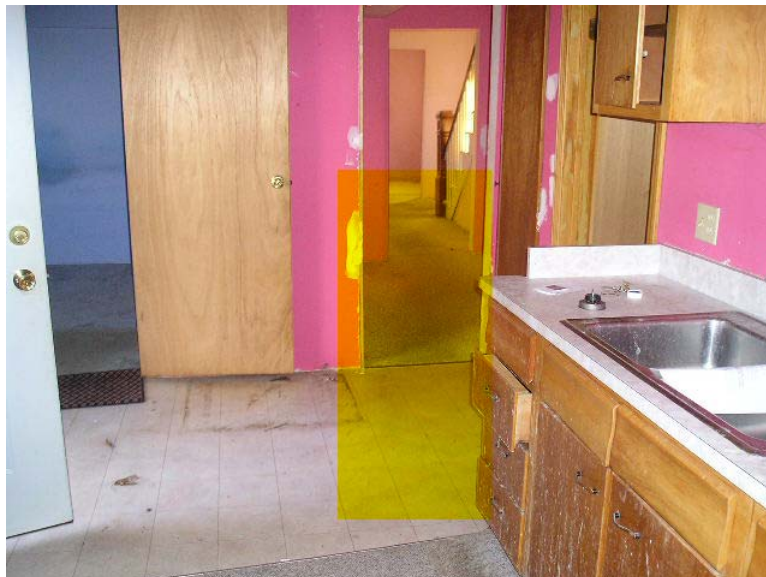
Shaded area shows interior area along center of building which has settled significantly. This has caused the majority of floors to slope toward the center of the building.

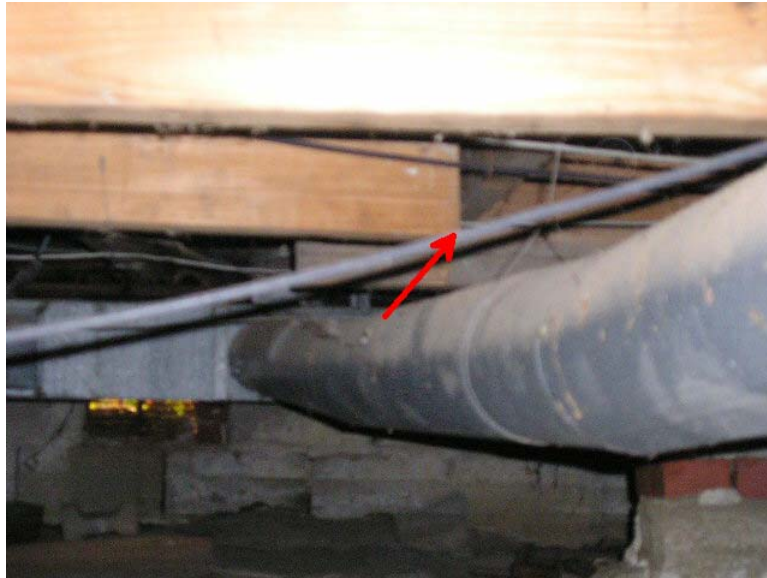
Floor joists are spliced without proper support at splice point. This can cause floor settlement and has a high likelihood of failure.

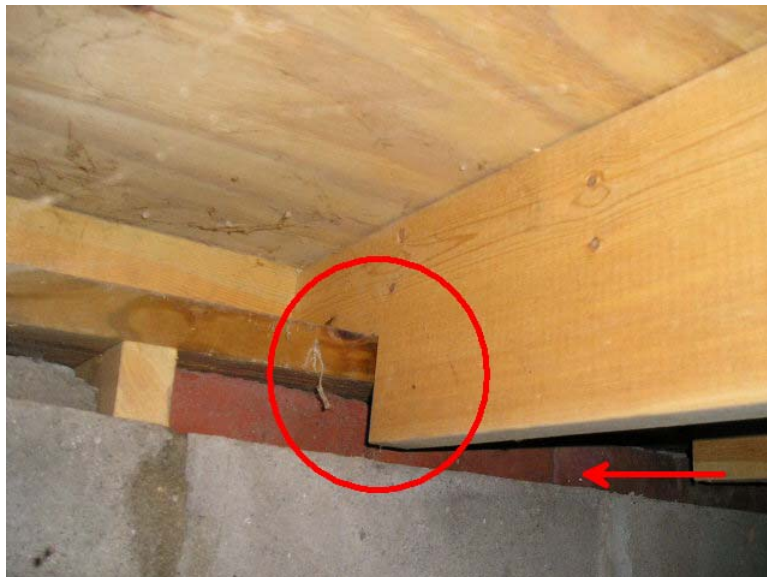
Floor joist improperly cut/notched and improperly supported at sill plate. The joists along the wall line are in danger of failure due to poor placement of cuts. Pointer shows area where sill plate is missing altogether. The sill plate acts to tie the floor and exterior walls to the foundation.

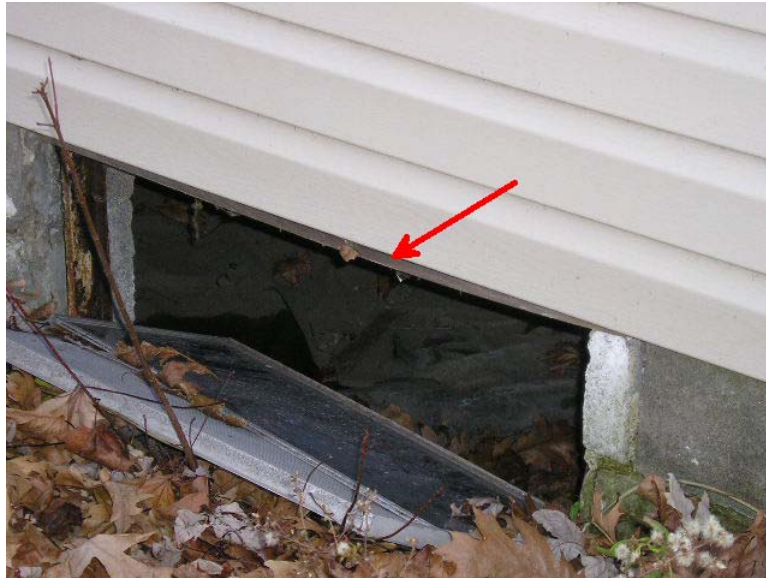
Frame around opening to crawlspace has rusted away. This leaves the crawlspace exposed to extreme weather conditions which could freeze plumbing supply and/or waster lines and also adds another avenue for water penetration into the crawlspace.

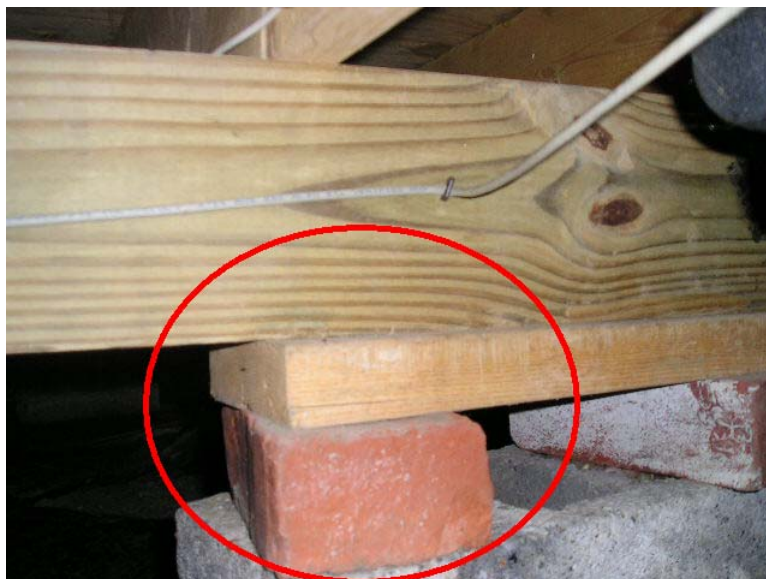
Improperly supported beam which supports floor joists. This support system is inadequate for the loads imposed. The installation was performed without placing a vapor break (plastic) between masonry and framing. This allows water to wick up the masonry and will cause framing to rot and/or compress and will eventually cause failure of the beam.

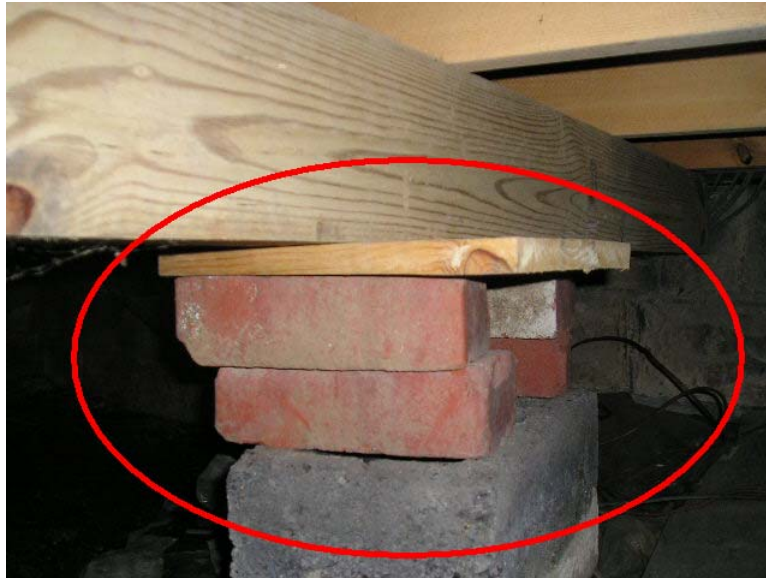
Another case of improperly supported main support beam. The beam is placed directly on shims/masonry. This will cause moisture to wick into the framing and will lead to rot and/or failure of the component.

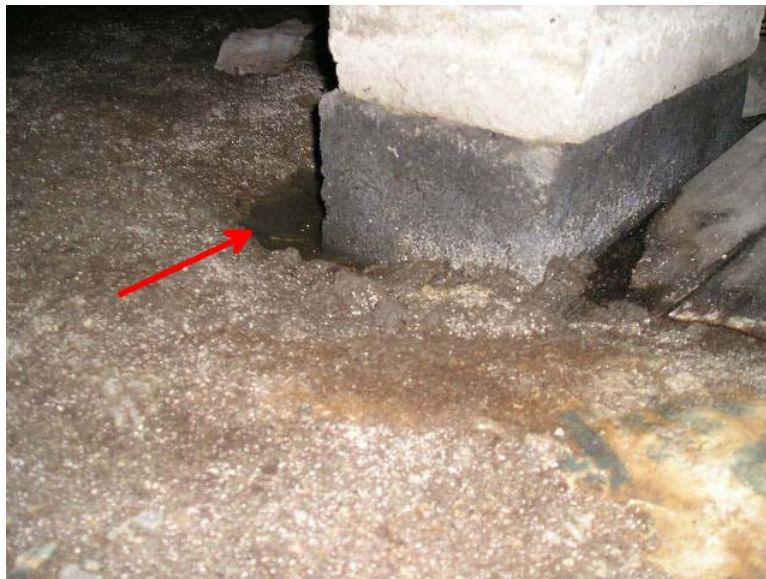
Concrete block supporting main floor beam has settled significantly due to constant exposure to water which erodes the supporting soils. This is causing significant settlement in the floors within the building.

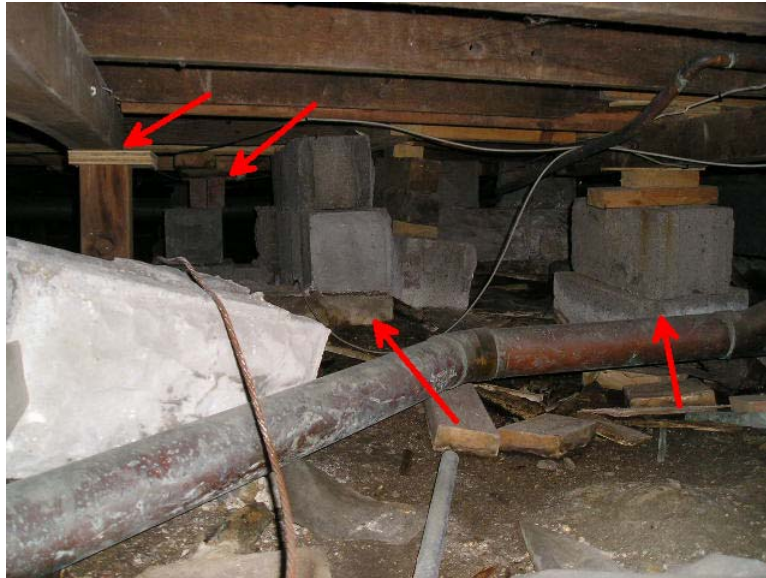
Pointers show leaning support piers in various locations under the main floor. The piers are all in varying stages of failure. Also note the wood and other debris on crawlspace floor. This has led to extensive microbial amplification sites which are partially to blame for moldy odors in building.

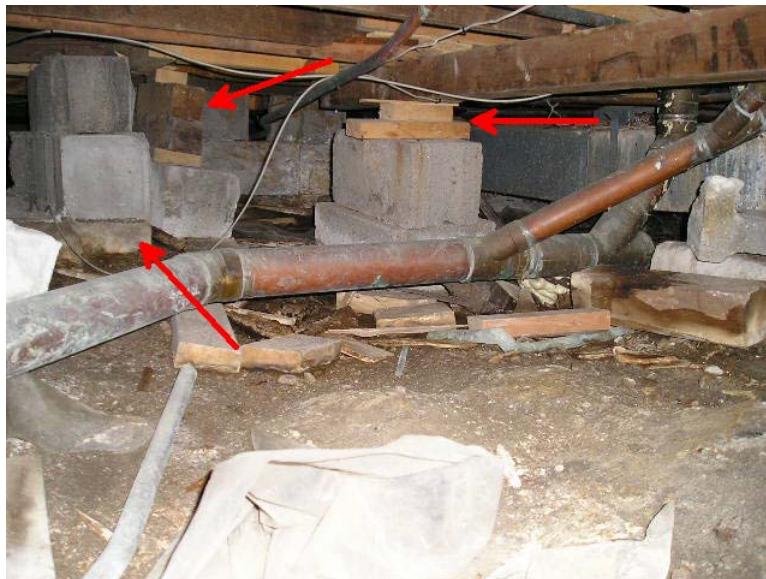
More failing piers in another area of crawlspace. Piers have settled and are no longer plumb. The piers will fail at some point if this situation is not corrected. The failure of any of these damaged piers could cause significant structural damage. Again, note the wet/rotted debris present. This is causing a significant amount of microbial amplification. This image also shows a partial, non-functional vapor barrier (plastic sheet on earth).

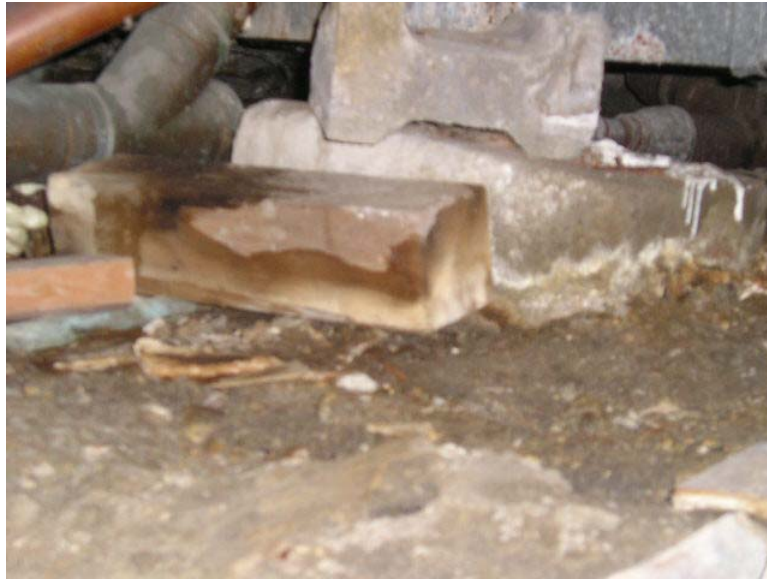
More debris and damaged piers in crawlspace.

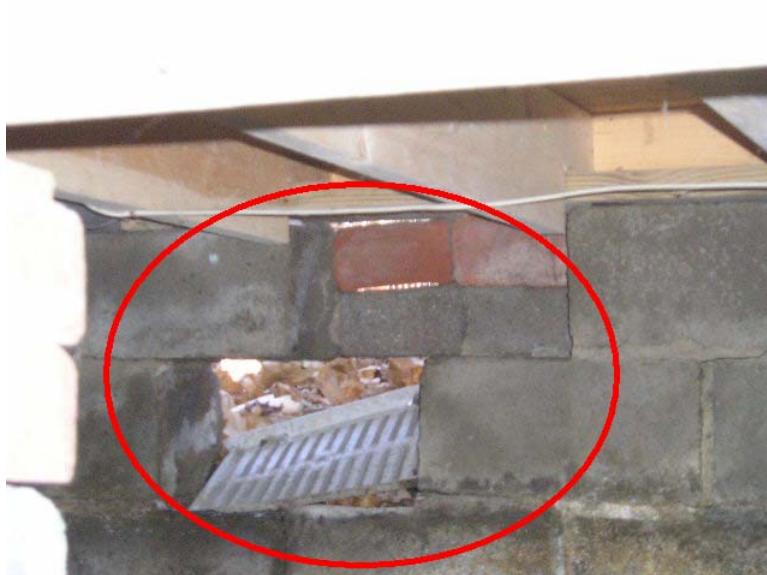
Daylight is visible through foundation walls in various locations throughout the crawlspace. The missing vent shows exterior grade which is higher than vent and is directing water directly into the crawlspace.

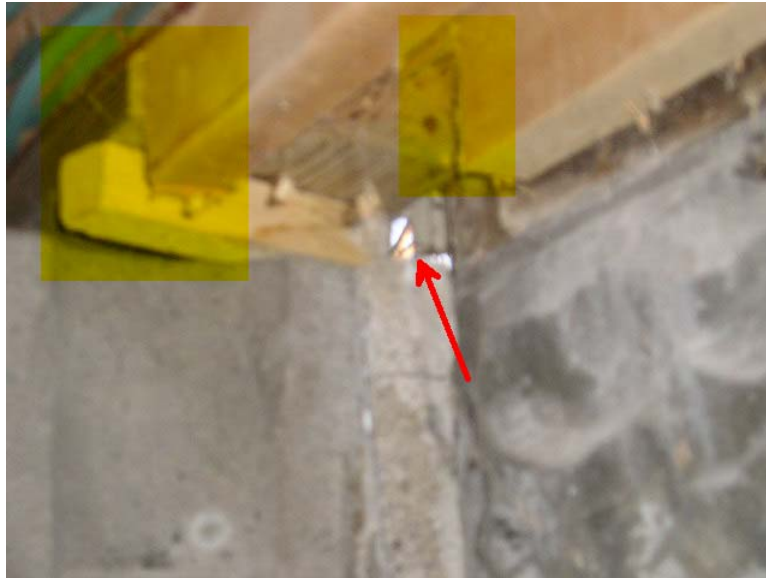
Shaded areas show improperly terminated floor joists. Pointer shows another area of foundation where daylight is visible through openings.

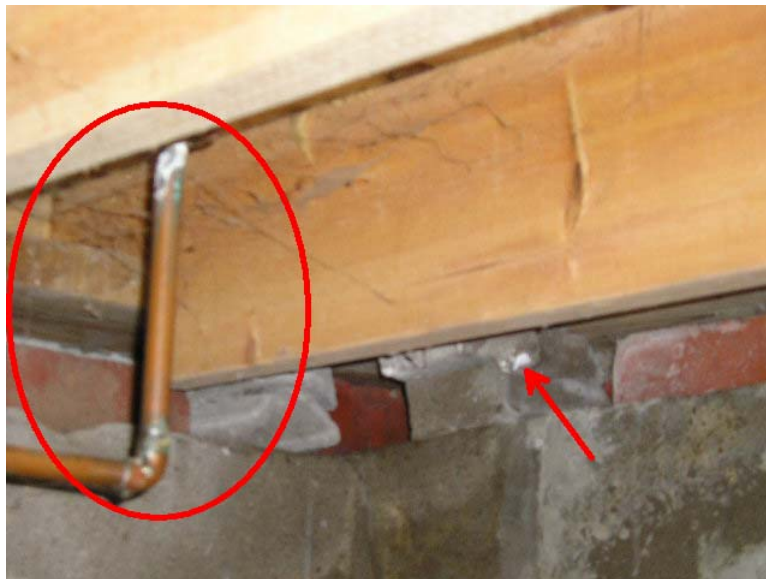
Improperly notched floor joist. Arrow indicates another opening to daylight through foundation.

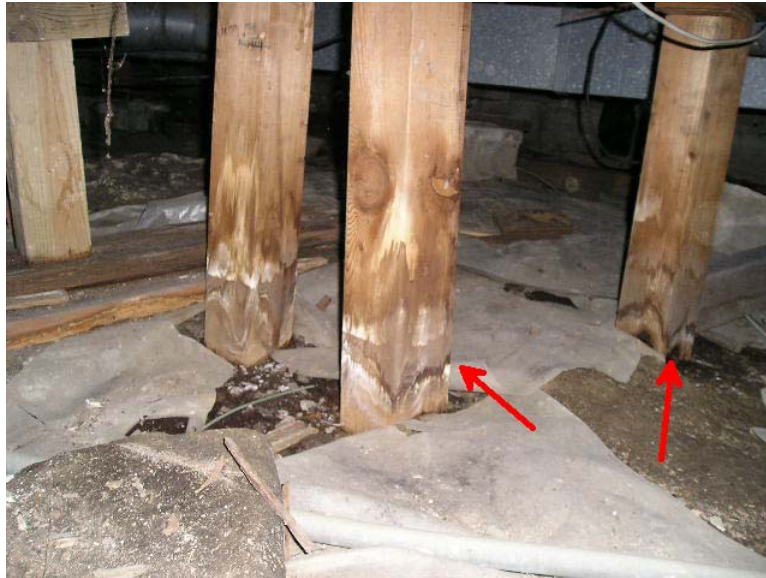
Wood has been improperly used to support floor joists in various locations. The wood supports are placed directly on earth causing moisture to wick upward via capillary movement. The supports are in various stages of deterioration and failure.

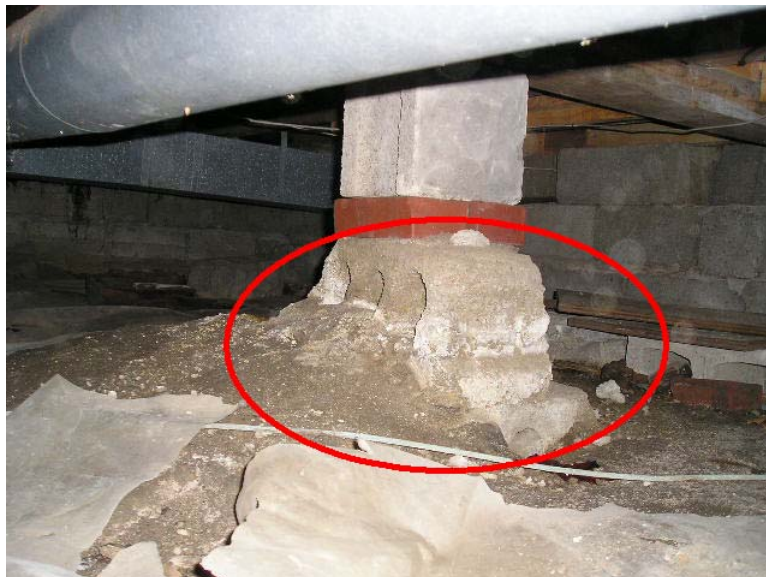
Masonry block is severely deteriorated from moisture exposure. This pier is a main beam support and is in danger of failure in the near term. This could cause significant ensuing damage to the structure.

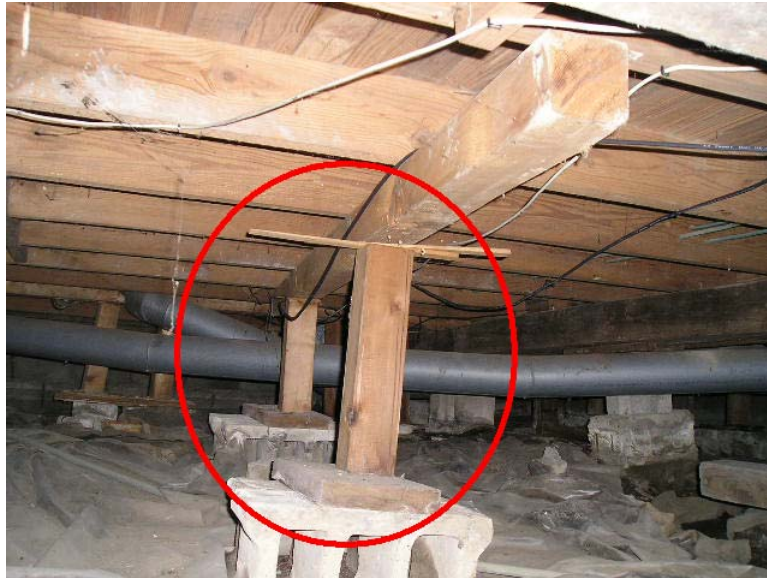
Improperly supported floor joists. These supports are deflecting causing the floor joists to move differentially. These piers do not meet acceptable construction practices.

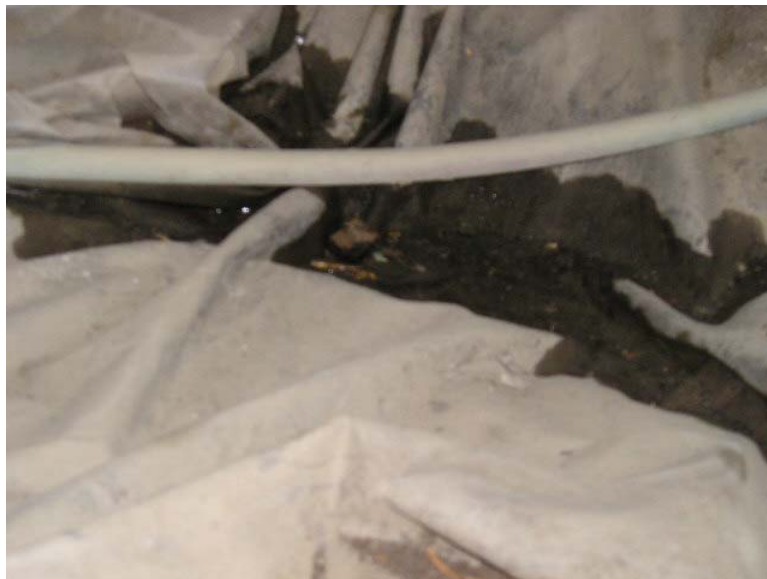
Water running through crawlspace on top of vapor barrier.

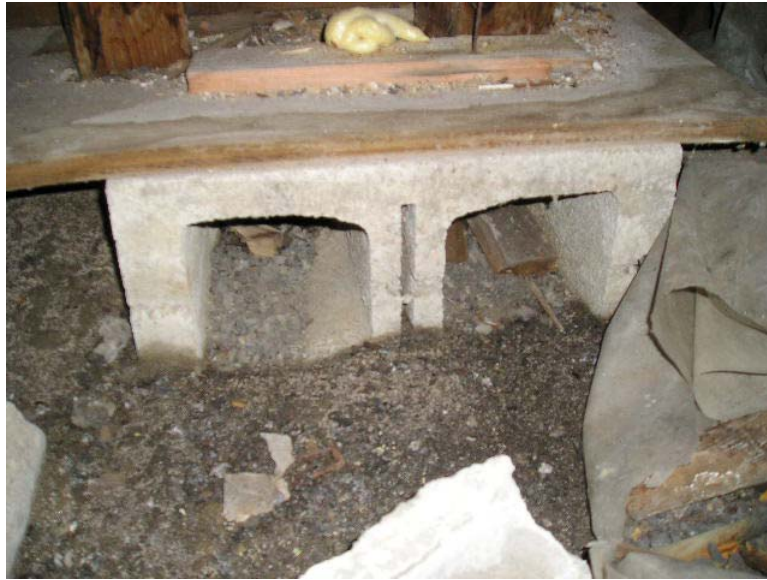
Masonry pier support has settled into the earth due to moisture exposure. This has caused significant settlement to occur in beams and joists.

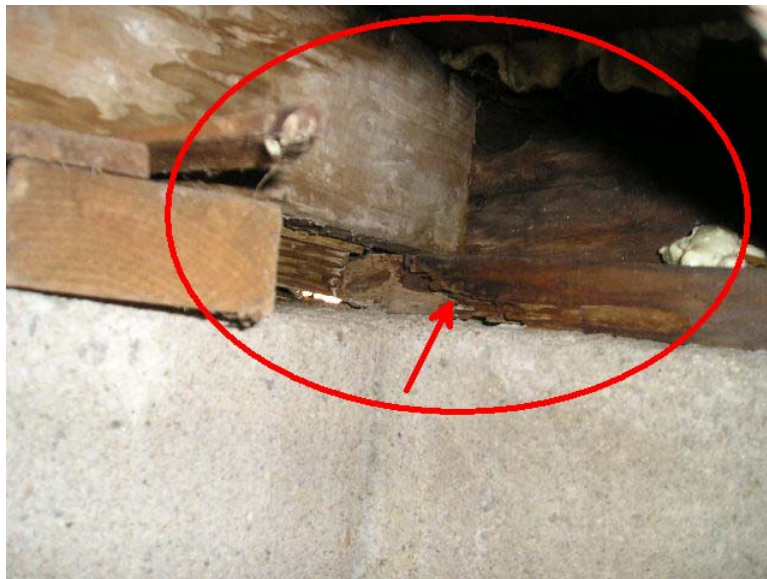
Area along sill plate shows rot and microbial amplification.
