# Energy Audit

**Property Address**  
0000 Anystreet USA

**Date** 2/19/2004

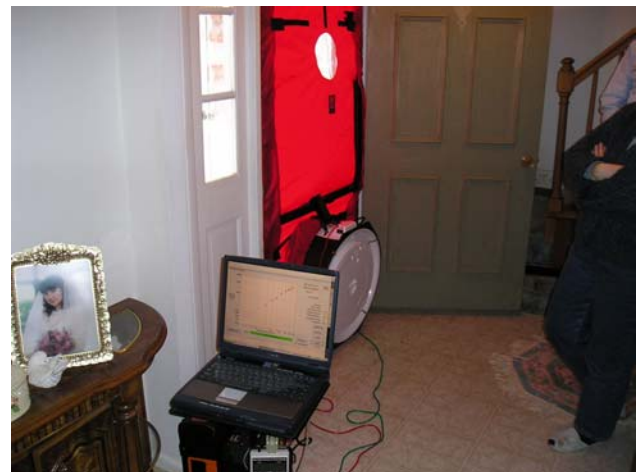
Blower Door setup and taking baseline reading

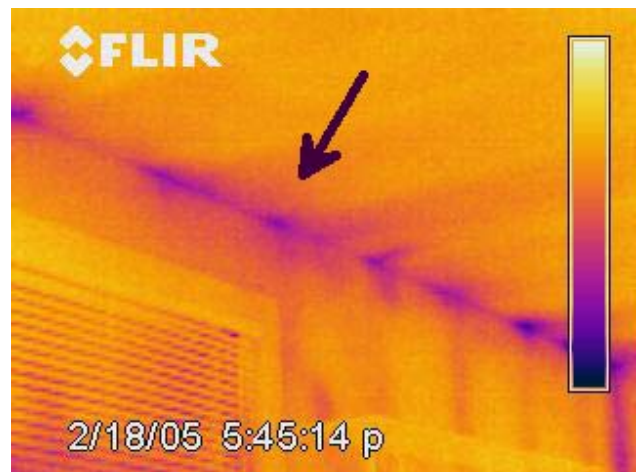
Typical leakage at wall/ceiling junction.  
Building was depressurized to 25Pa at time  
image taken.

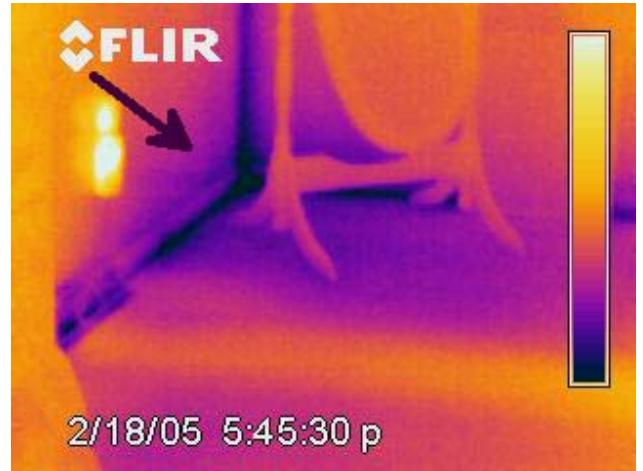
Leakage entering at base of wall.

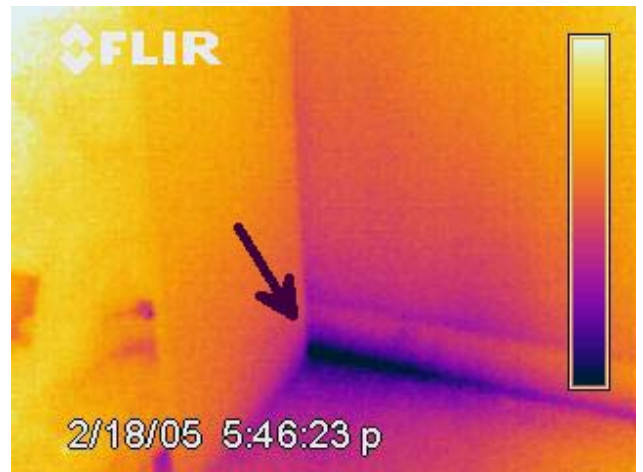
Leakage at base of wall

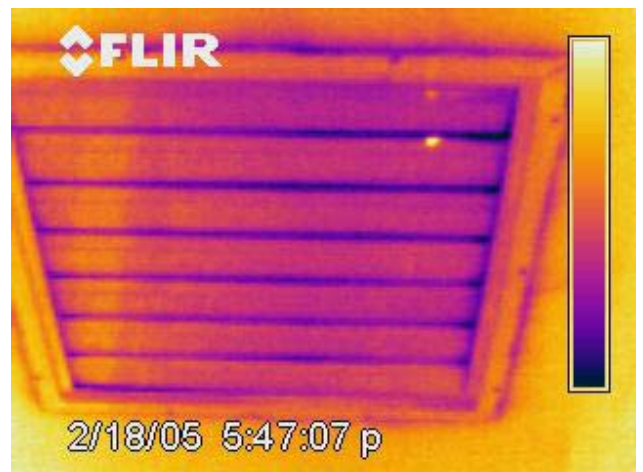
Whole house fan. These areas should be sealed in winter to prevent major heat loss due to stack effect

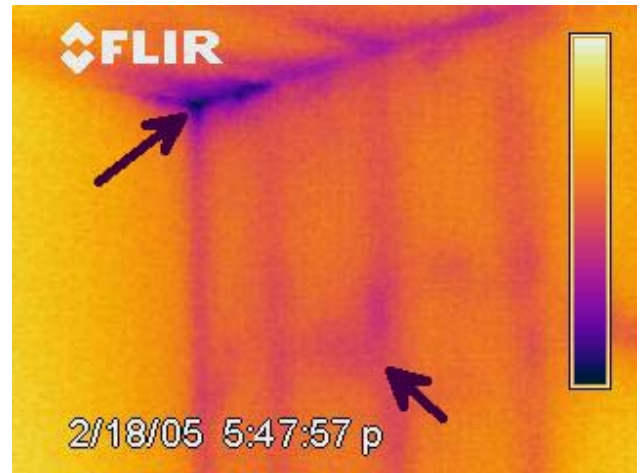
Darkest area indicates point of origin for cold air leakage. Lower pointer indicates potential gaps in insulation.

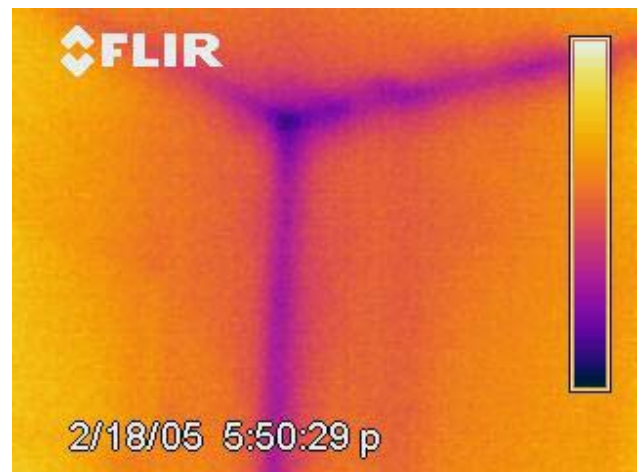
Typical corner detail indicates leakage due to 3 stud corners.

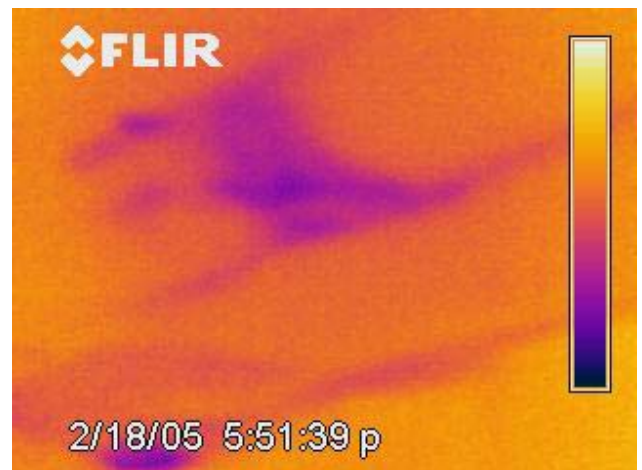
Anomalies along second floor ceiling indicate gaps in insulation. Evening out and/or adding insulation will address these leakage points.

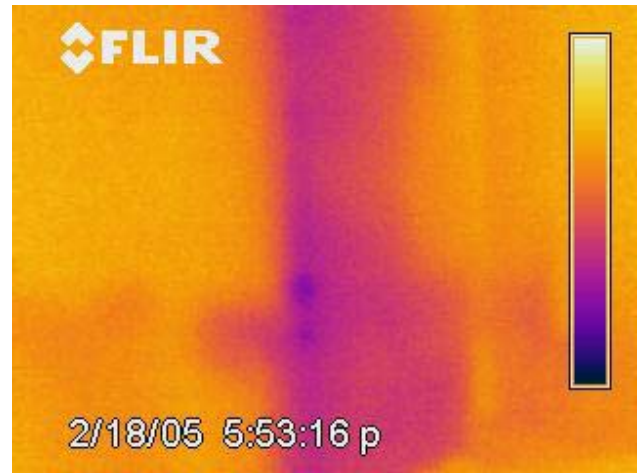
Wall in dining room indicates significant leakage. A satisfactory blown in dense insulation may be warranted.

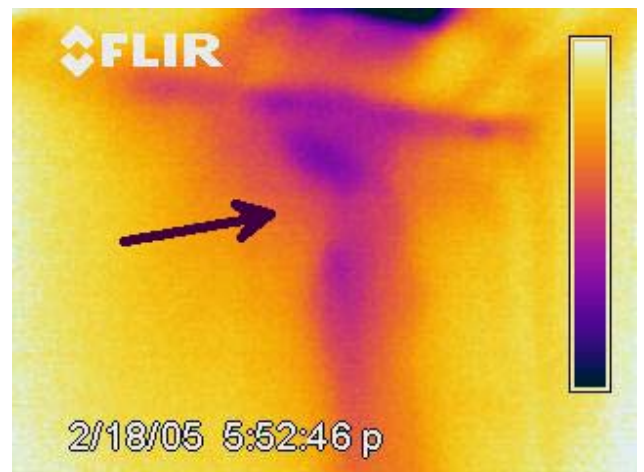
Significant amount of leakage indicated in vicinity of second floor bathroom exhaust. Note cold air pathway between wall studs.

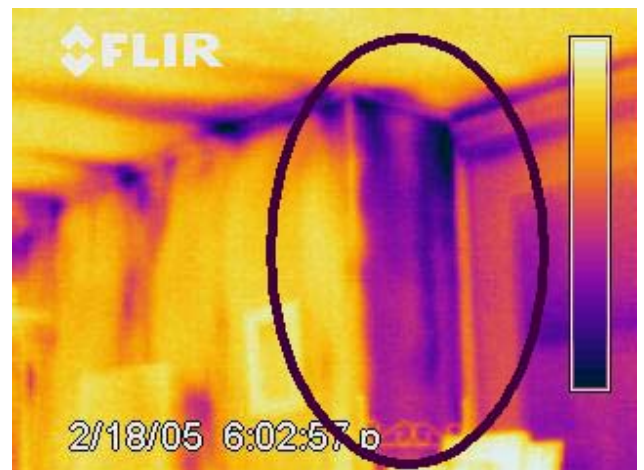
Note leakage pathway which travels between wall studs. Insulation improvements in this area are suggested.

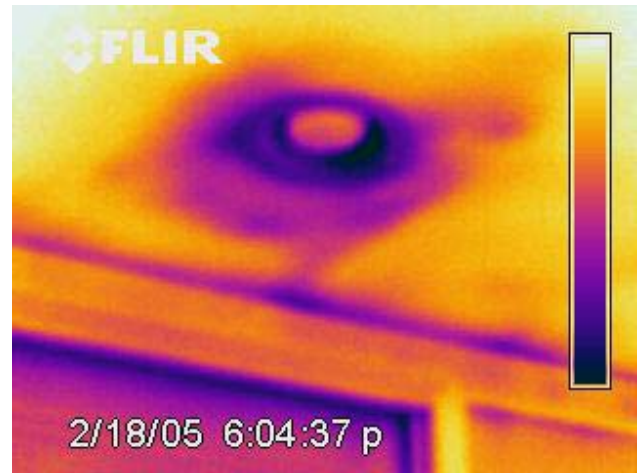
Canned lighting should be investigated for proper type and installation. This type of lighting is a typical leakage point.

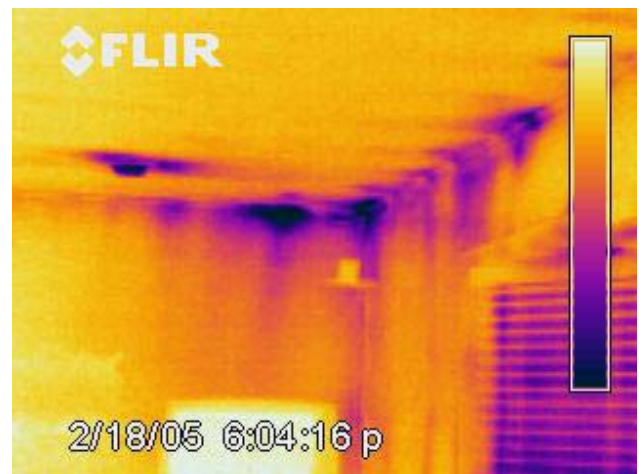
Image along wall/ceiling junction at second floor indicates significant leakage.

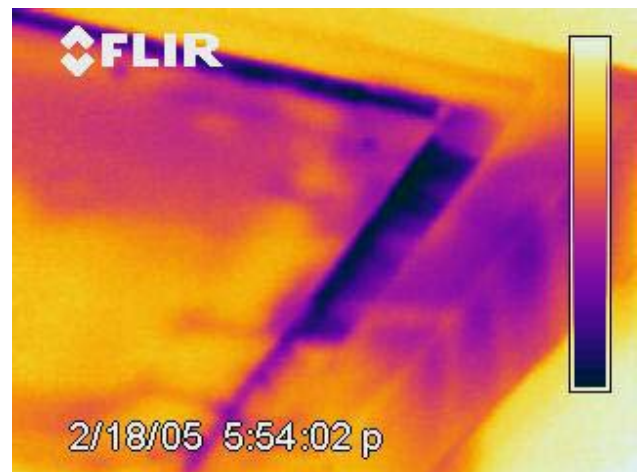
Leakage around attic pulldown stairway.
