Building Air Leakage & Thermal Bridging

Why a Bigger HVAC System May Not Make You Comfortable

Al Tibbs, LEED AP, CIEC, CIAQT C.L.I. Group, LLC

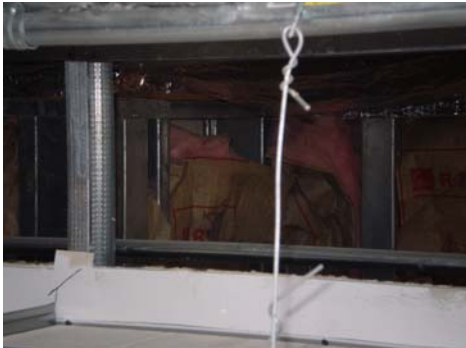
Our investigation and evaluation of the building revealed some very serious problems in both the design and construction of the building. First, we knew that the building was framed with steel studs. This requires some additional thought and calculation during the design phase of the building. The photo shows fiberglass batt insulation between studs which has fallen, leaving little to resist heat flow at the exterior wall.

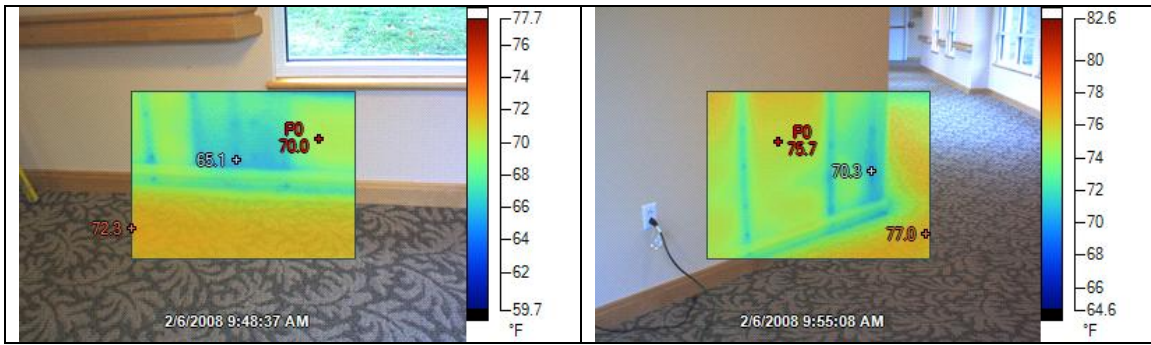
The first part of our investigation was to perform a thermographic analysis of the building enclosure to determine where the potential for problems was occurring. The results of the thermographic analysis were astounding. The images below show the extent of the thermal bridging and air leakage which we discovered. In some locations, we found a 20+ degree F. difference in surface temperature from the studs to the center of cavity.

This told us that the potential for condensation was significant. We needed to have a better understanding of the building enclosure design and construction. Further evaluation of both the drawings and specs and the building revealed some very significant shortcomings which would be hard to correct.

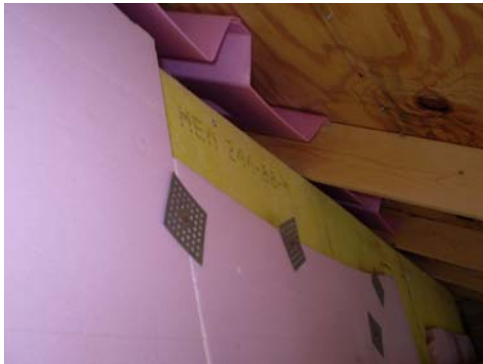
First, the installation of the sheathing and exterior insulation was not done properly, leaving uncontrolled airflow into the building and unacceptable resistance to heat

flow. The steel stud wall construction exacerbated the problems even further. The joints in the polystyrene insulation and the sheathing were aligned and neither had the joints sealed. This allowed for air to flow into the wall cavity and create what is known as “wind-washing” in the wall cavities. The R-values of all exterior walls were extremely compromised. In some areas, the interior wall surfaces were 15-20 degrees F. colder within an area of a few feet. The thermal images below show the extent of the thermal bridging which was taking place. Modeling of the wall (see below) revealed an effective R-value of less than 5.

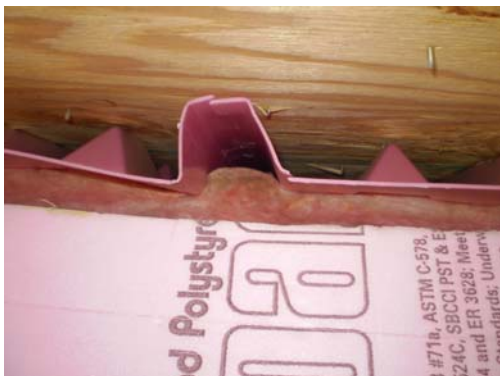
The photo to the left was taken from the soffit area at the exterior of the building. Note that the fiberglass batt insulation edge is exposed to outdoor airflow. This answered our questions about the frozen sprinkler lines. Our pressure assessment indicated that the building was under negative pressure with reference to the outdoors. This was partly due to an attached building which was exacerbating the uncontrolled airflow into the drop ceiling

where the sprinkler piping was located. The fiberglass baffles which were installed between rafters were not performing their intended function which is to

separate airflow from the insulation. This scenario greatly reduces the resistance to heat flow through the insulation.

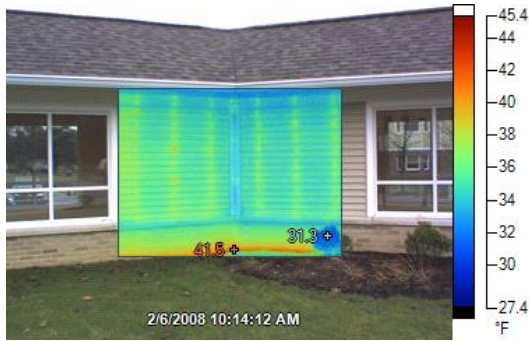
Thermal bridging through the steel stud wall construction was apparent when a thermal scan was performed from the exterior. A significant amount of heat loss is also apparent at the top of slab. This told us that further investigation of both air barrier and insulation/sheathing installation was warranted.

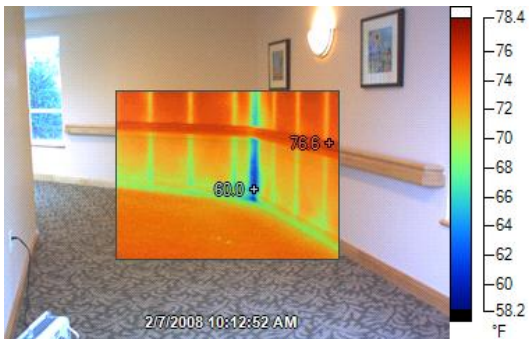
Below is an interior view of the same area. The extensive thermal bridging is made very evident using infrared thermography. This can save valuable time in directing an investigation.

Note the anomaly which indicates air leakage at the change of direction in the wall. This is sometimes where architecture and building performance go their own ways. The plane of air tightness most often fails at these changes of plane in the wall. This is where additional attention in the design and installation is required to assure success.

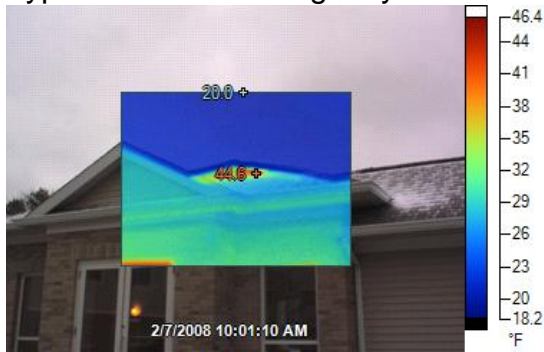
In addition to air leakage issues in this building we found a few other areas where a closer evaluation during plan review would have spotted some other potential problems. One of these areas was the placement of the air handlers (2) in the attic. In addition to comfort complaints and frozen sprinkler lines, the owner complained of large ice buildup at the eaves. Our infrared thermography assessment revealed this almost immediately when the exterior was scanned. The image below shows that the roof above the area housing the air handlers was 44 degrees on a day when the outdoor temperature was in the 20's.

A trip up to the space used to house the air handlers revealed some significant problems including poor insulation, significant amounts of air leakage around the plenums and a disconnected supply duct. How do you spell RELIEF in such situations? COMMISSIONING!! The owners could have avoided many serious and expensive problems had they opted for some form of commissioning.

Typical commissioning may not have discovered the problems. This project shows the need for “total building commissioning”.
