C.L.I. Thermal Imaging

Technology Proves Valuable in Building Damage Surveys

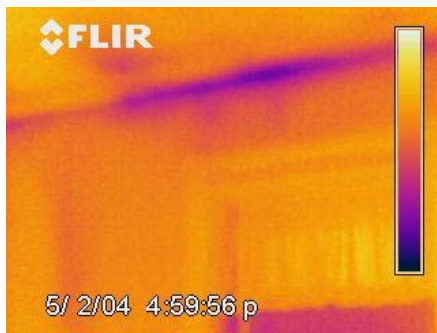
The image shows an infrared image taken along the wall/ceiling line in a home with a suspected roof leak. By isolating the area where the suspected leakage was occurring, the cost of repairing the problem was minimal and the source of the problem was more easily determined and corrected.
