Moisture/Mold Assessment

Property Address
Water Damaged Condo

Date 3/4/2005

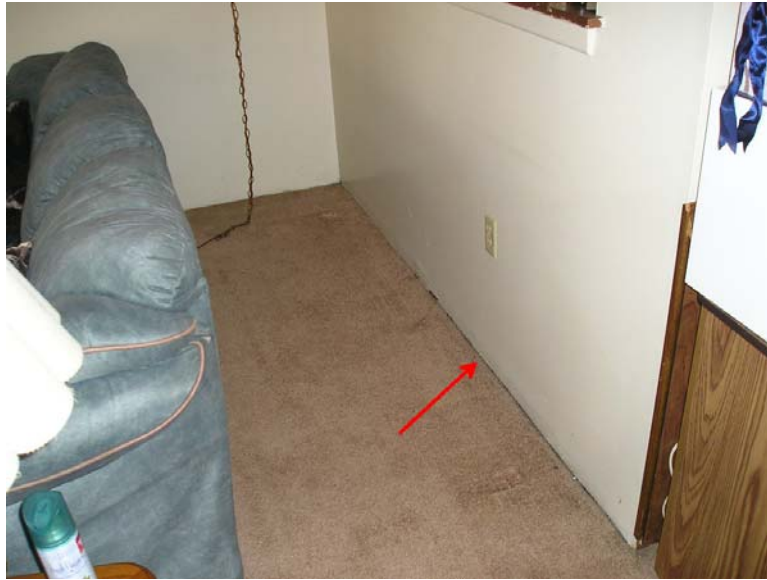
Area of concern shows some indication of moisture along base of wall.

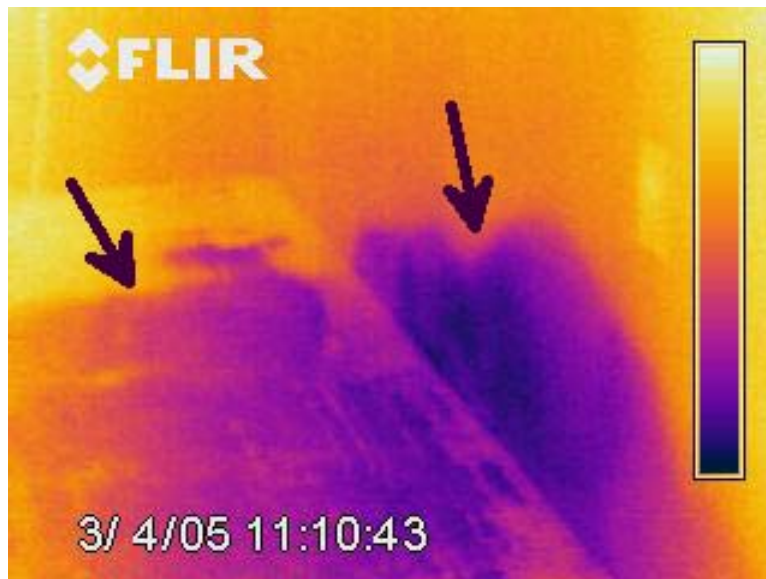
Same area viewed using infrared thermography. Thermal anomalies indicate large areas which are water damaged. The areas include wall, carpet and couch which sat above wet carpet. The thermal anomalies were verified using a Delmhorst electronic moisture meter. Carpet and wall were also wet to the touch.

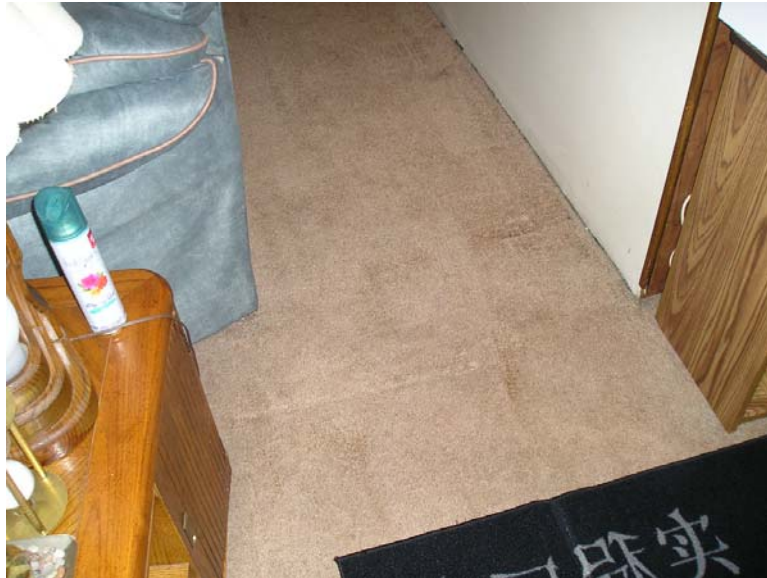
Area at beginning of wall between kitchen and living room shows limited signs of moisture damage.

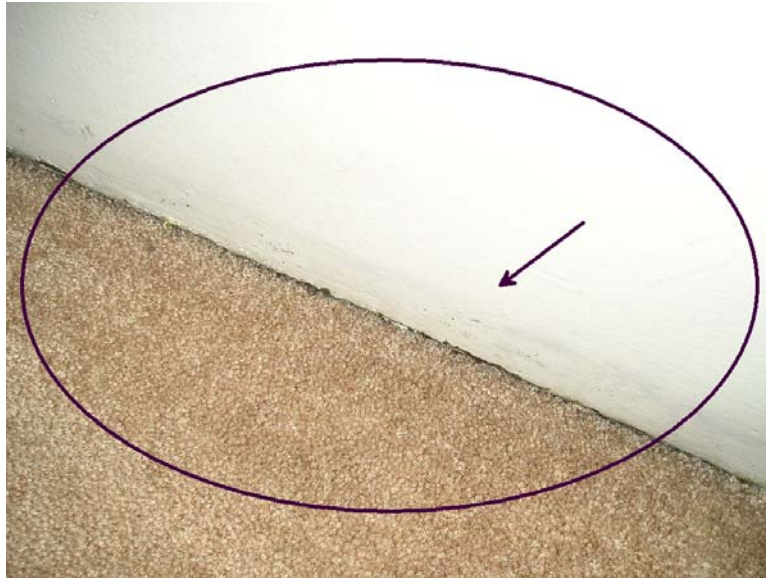
Another view at base of wall shows some more detailed indication of moisture at base of wall.

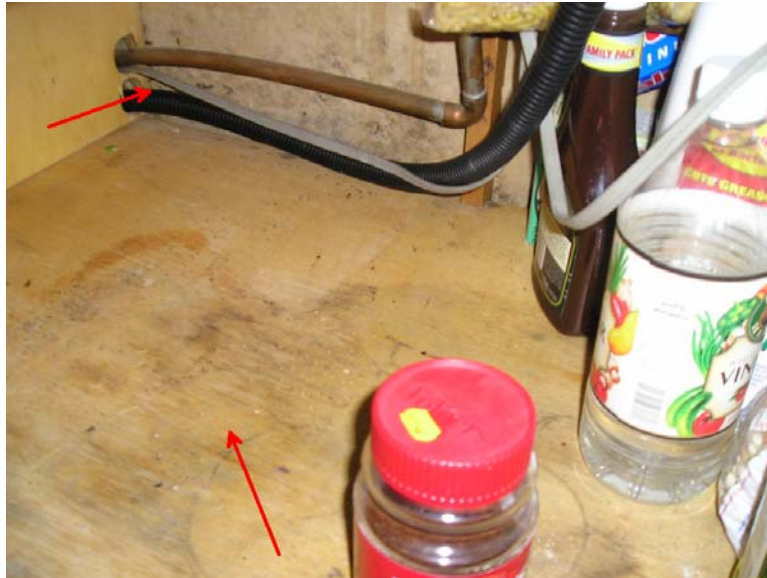
Pointers show areas under sink base cabinet in kitchen which have visible indication of water damage and fungal amplification.

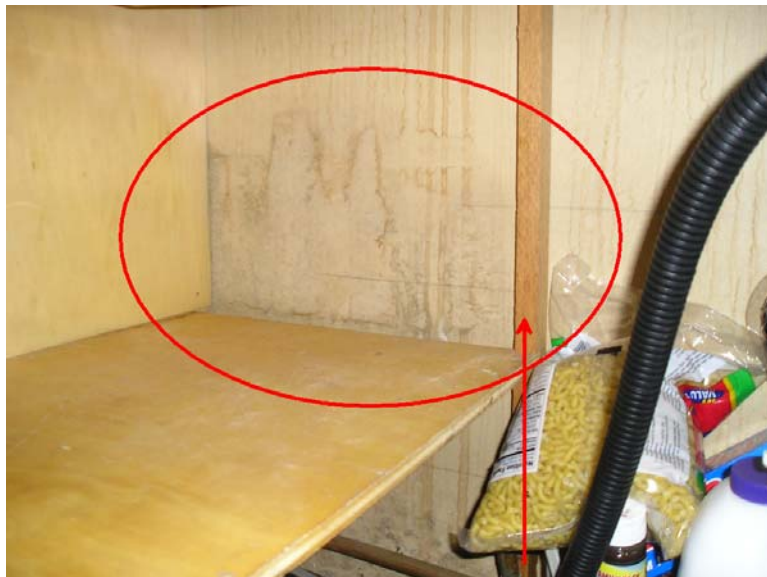
Encircled area shows indication of moisture (staining). Pointer shows direction of moisture wicking in wall behind sink base.

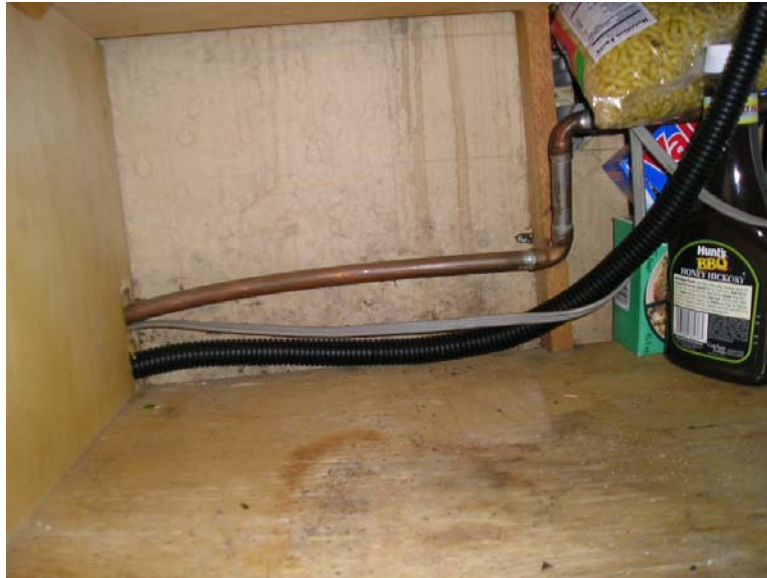
Area under sink base in kitchen. This area is adjacent to dishwasher which is suspected as source of leakage.

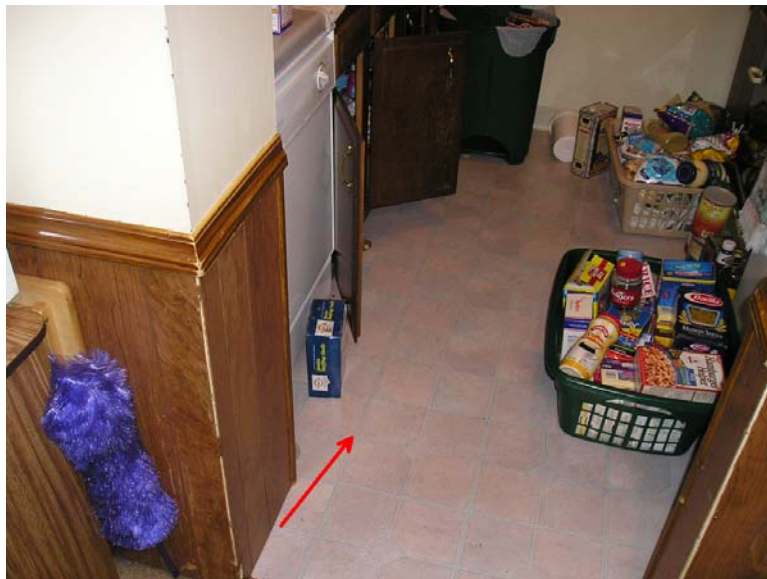
Resilient floor in kitchen shows some indication of moisture damage. Some areas are loose and seams are open.

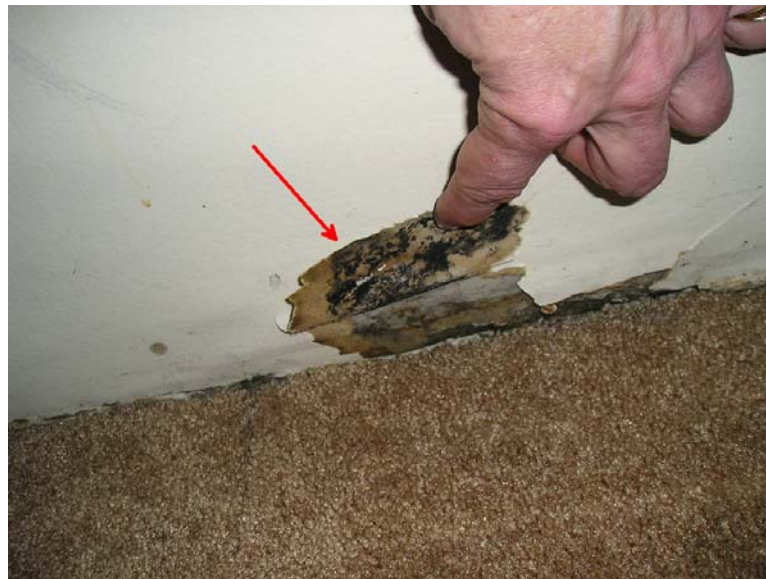
Peeling paint at base of wall was lifted to reveal fungal amplification under paint/paper. There is a high probability of extensive fungal amplification inside of wall cavity, under carpet and in couch.
