Property Condition Assessment

3030 Smith Rd.
Anywhere, OH 00000

5/7/2004

C-050704-1

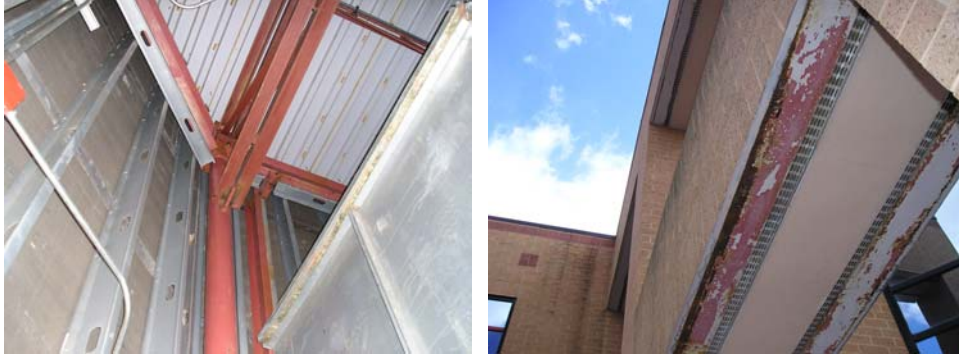
3.2.2 Water damage to foundation in stairwell to basement area was noted.

3.2.3 The lintels above the windows and doors in the pre-cast curtain wall and masonry façade are corroded and deformed. This appears to be due to moisture accumulation on the steel. As steel corrodes, it expands. The expansion of the steel has caused cracking in the masonry above the top corners of the windows and doors. Although this is not a major structural concern, ongoing cracked of the masonry and the need for periodic repairs should be anticipated.

Replacement of this steel is not considered warranted at this time; however, the steel should be scraped clean and repainted to minimize future corrosion.

Recommendations		Costs	Time Frame
3.3.1	Repair damaged steel lintels	Over \$10000	Immediate

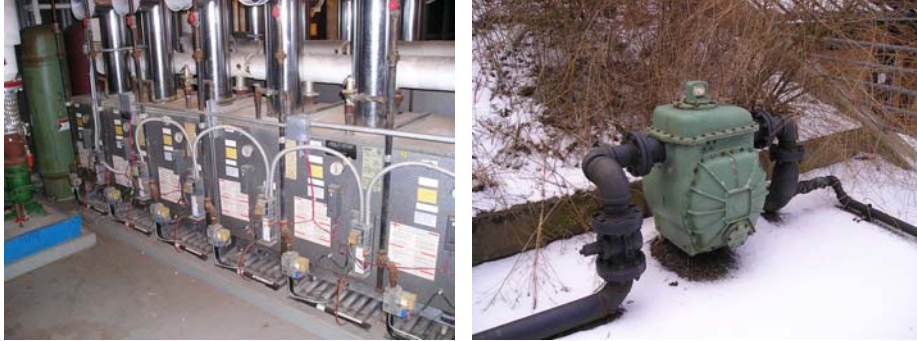
The building is heated by a 12 section, sequentially fired, HydroTherm gas-fired, hot water boilers, with a combined output of 300,000 BTUS per hour per section.

5.2.6 No major deficiencies were noted.

Recommendations		Costs	Time Frame
5.3.1	Service heating equipment.	Minor	Discretionary (as needed)

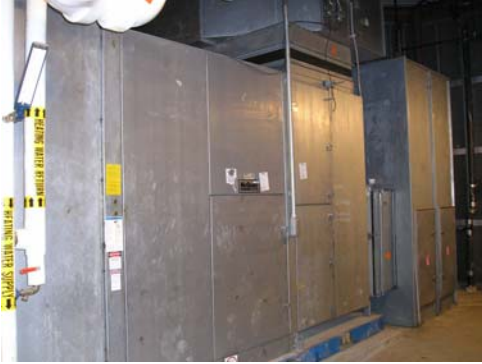
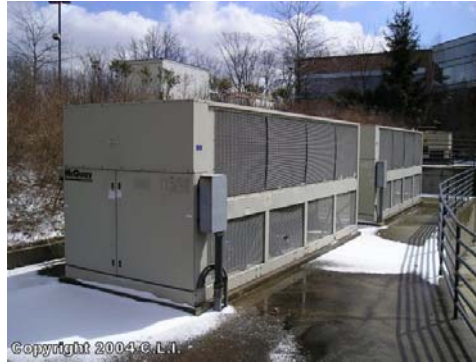
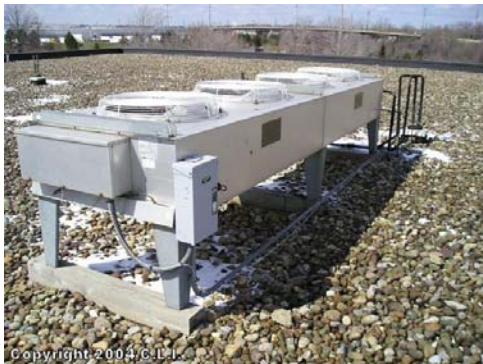
The building is air-conditioned by two air cooled chilled water systems. These are McQuay systems model number ALR125C and are located near the loading dock. Supplemental system located on rooftop.

- 6.2.1 The chillers are in the 12th year of a 15-20 year life cycle. Reserve funds should be anticipated for repairs and maintenance.

Recommendations	Costs	Time Frame
6.3.1	Service air conditioning equipment.	\$3000 - \$4000
		Three Years

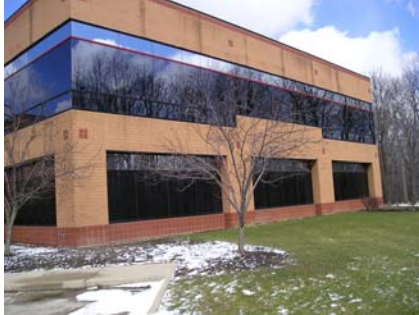
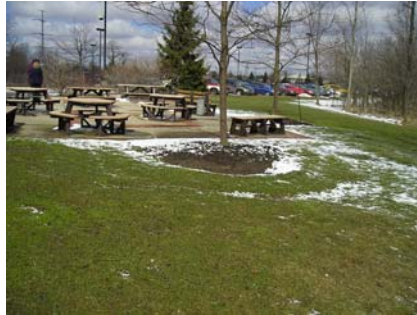
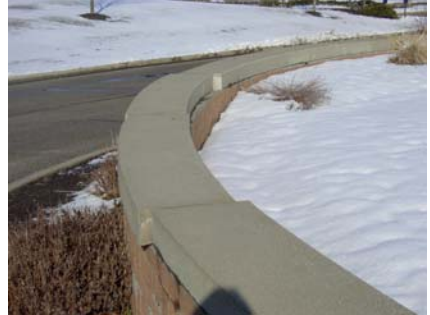
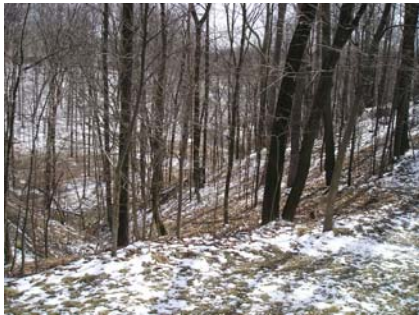
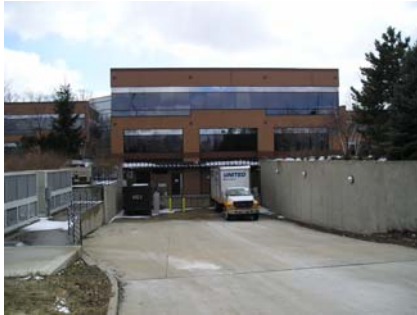
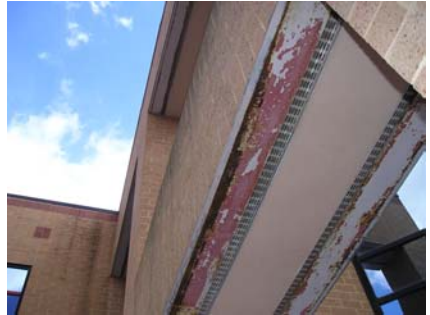
The exterior walls are clad with brick veneer and aluminum curtain wall system. The penthouse is covered with E.I.F.S.
