Buildings Are Getting Greener, But Are They Getting Better?

Do Green Labeled Building Materials or Certification Guaranty Success?

Al Tibbs, LEED AP, CIEC, CIAQT C.L.I. Group, LLC Cleveland, Ohio

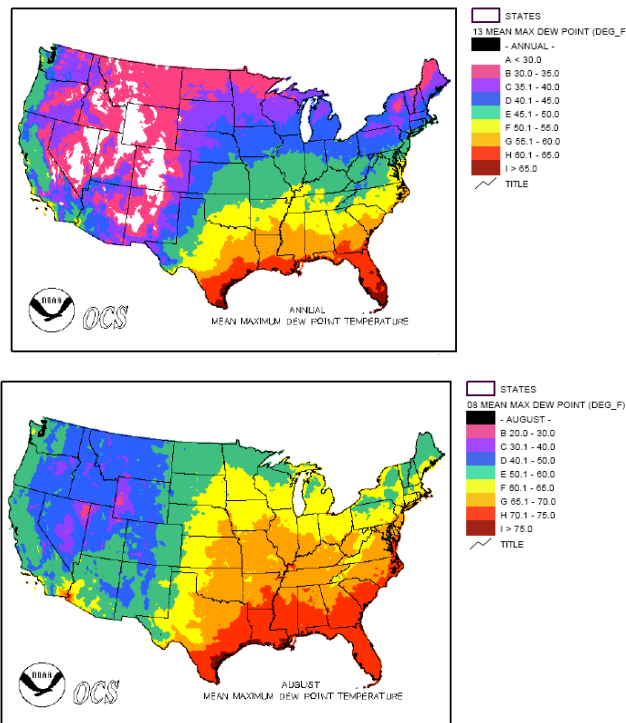
The N.I.B.S. Guideline 3 for enclosures is long overdue. The enclosure is critical to the overall performance of the building and is especially important to properly sizing, operating and understanding the HVAC systems, building pressurization, etc. The number of moisture and mold related issues in buildings today attests to the fact that the enclosure is all too often overlooked and/or over simplified by designers. Below are two maps showing mean max. dew point temperatures for the U.S., the first showing annual mean max. dew point and the second showing mean max. dew point for August. Looking at Ohio for example, if the design team uses the annual figures and underestimates the air infiltration through the building enclosure, the systems may not be able to adequately remove moisture in August when dew point temperatures are considerably higher on average.

The conditions discovered during our investigation of the problems in this building also show what air infiltration can do to a building. As shown in the mean max. dew point maps above, depressurization, coupled with high dew point temperature in months such as August and the temperature of steel studs and ducts below the dew point equal several opportunities for moisture problems to occur. These issues would have all been discovered during commissioning during either the design phase or construction phase of the project and could have been corrected at little or no cost.
