BUILDING LEAKAGE CURVE COMPARISON

Closer Look Inspections
Construction, Environmental & Energy Consultants
34090 Roberts Rd.
Eastlake, OH 44095
Phone: 440-946-7191

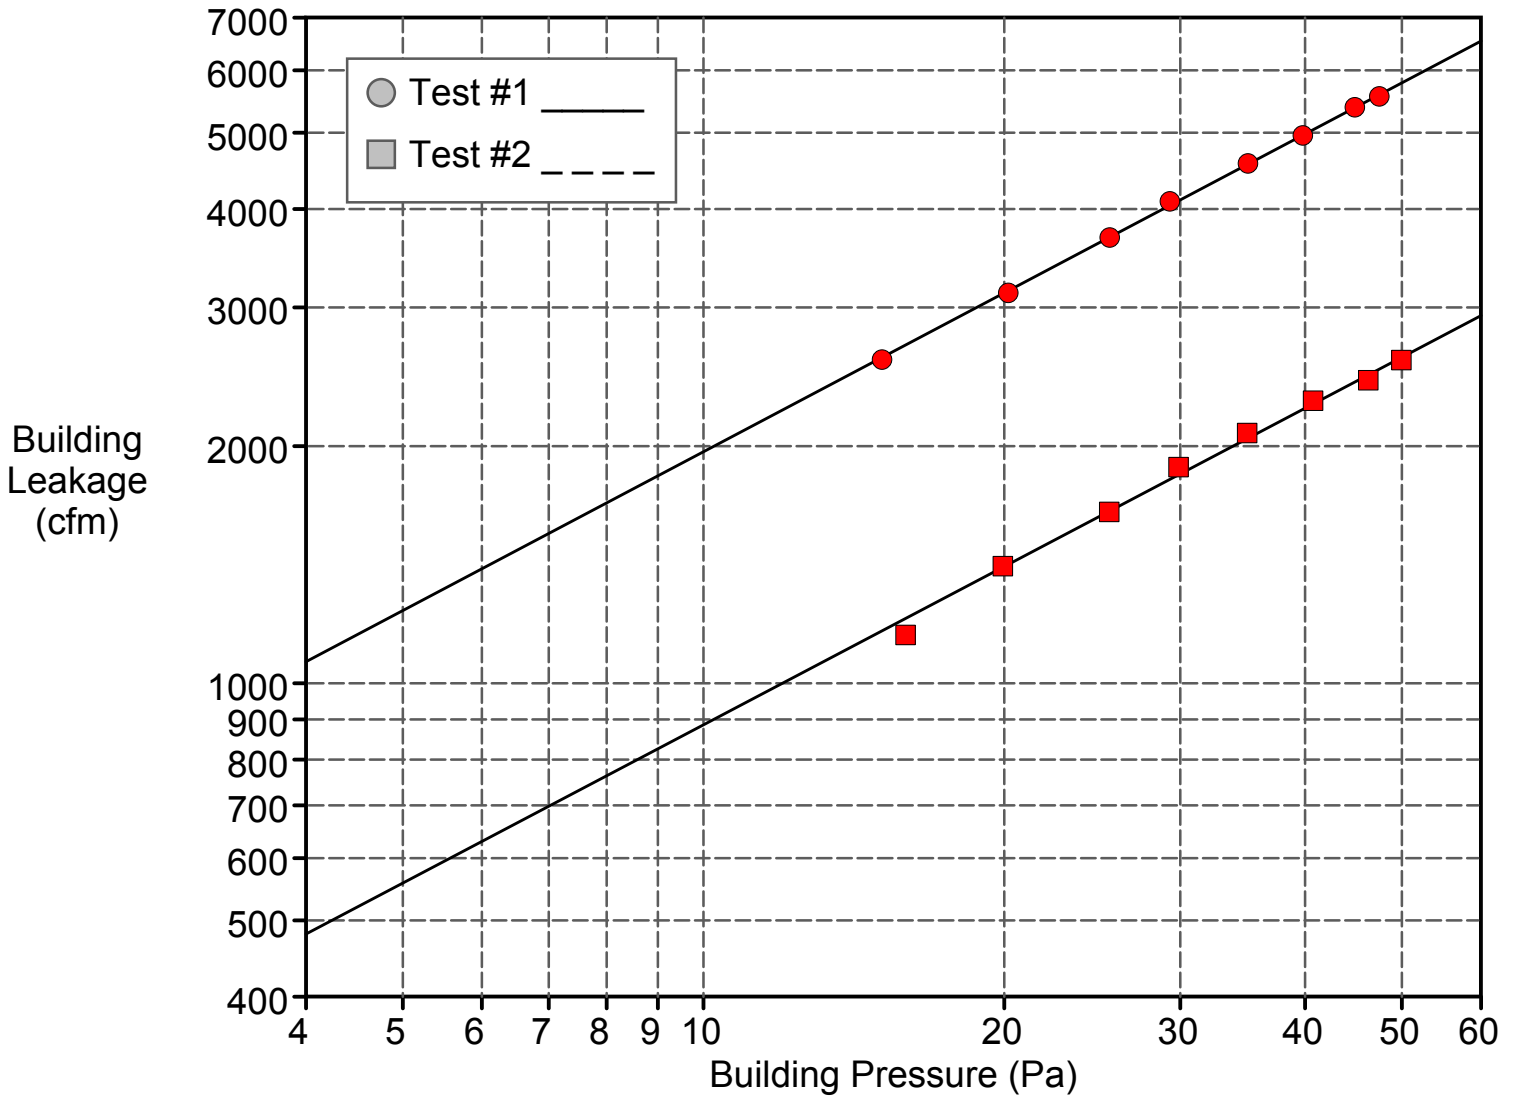
Test #1

Test File: testhouse1
Date of Test: 11/3/2005

Test #2

Test File: testhouse2
Date of Test: 12/16/2005
